Five-Counties Post-project Monitoring Report for the Digger Creek Culvert Replacement Project at Ocean Drive, Coastal Mendocino County: Post-project Survey #2.

**Ross Taylor and Associates
1254 Quail Run Court
McKinleyville, CA. 95519
www.rosstaylorandassociates.com**

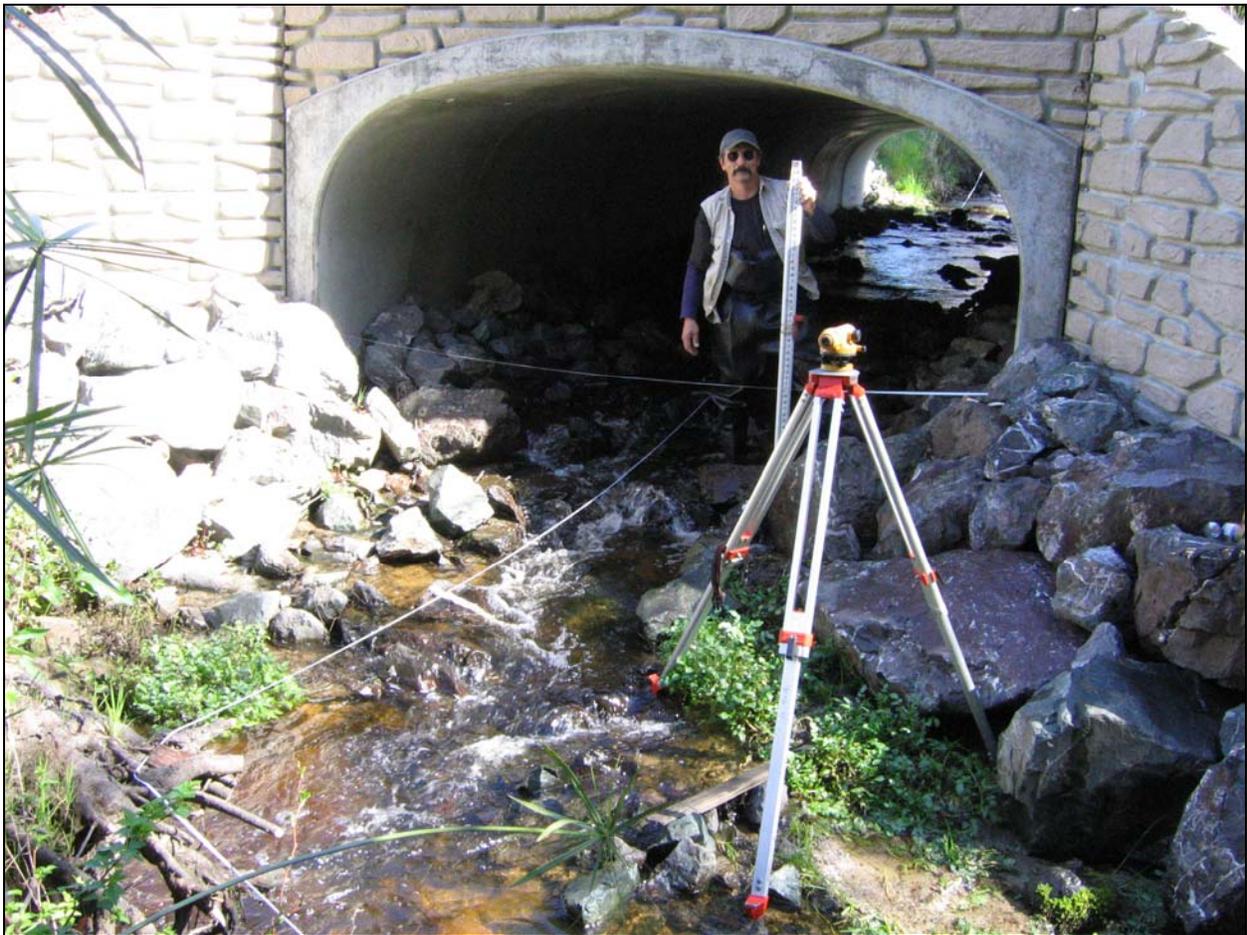
Digger Creek at Ocean Drive – outlet photo taken on March 10, 2005

A concrete open-bottom arch culvert was installed during August and September of 2003 by Mendocino County DOT. The culvert's dimensions were 60'L x 12'W x 4'H (see cover photograph). The stream bed through the new crossing was lined with angular cobble to small boulders to provide roughness to create adequate depth for fish migration, as well as reduce velocities through the crossing.

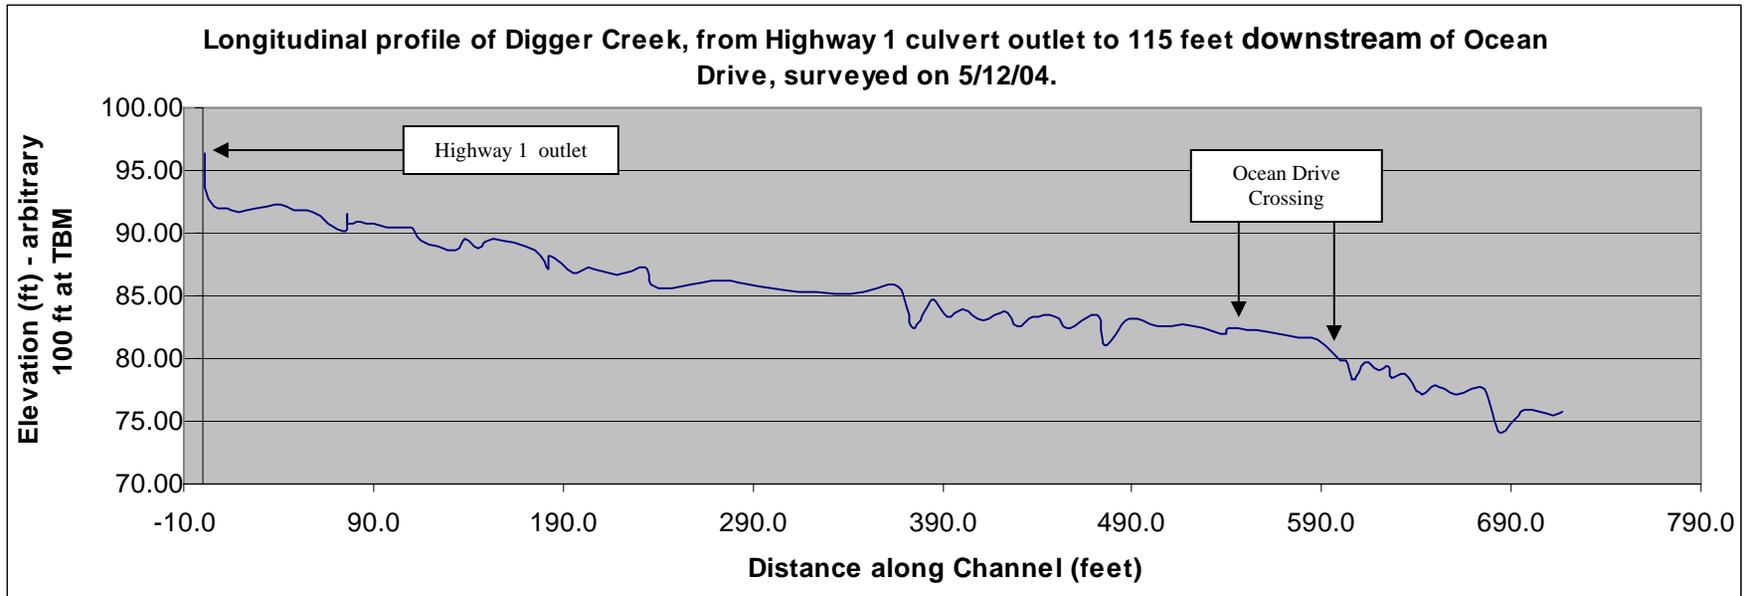
Figure 2. Longitudinal profile of 717 feet of Digger Creek’s channel surveyed on May 12, 2004.

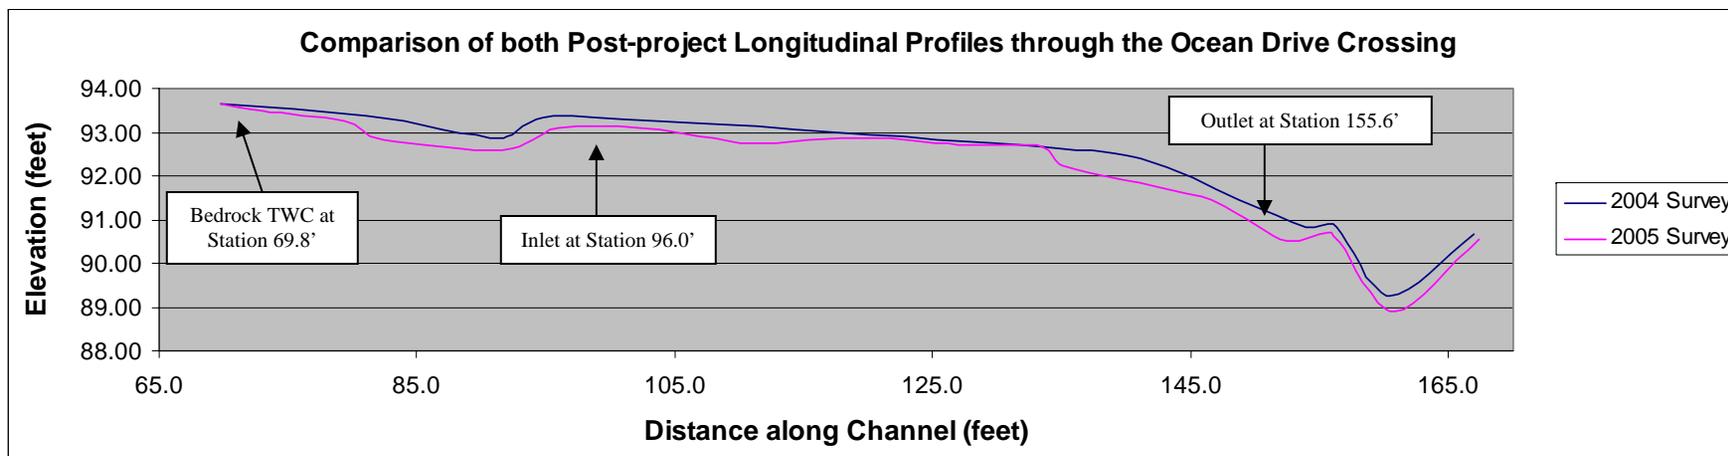
Figure 4. Longitudinal profiles of Digger Creek through the Ocean Drive open-bottom arch, surveyed on 5/12/04 and 3/10-05.

The new crossing is a significant improvement in both fish passage and storm flow conveyance in contrast to the old culvert. Currently, the slope through the new crossing is still a bit steep at the downstream end. However, this over-steepened section has already re-adjusted during 2004-05 winter storm flows and has decreased in slope when compared to the initial post-project survey.

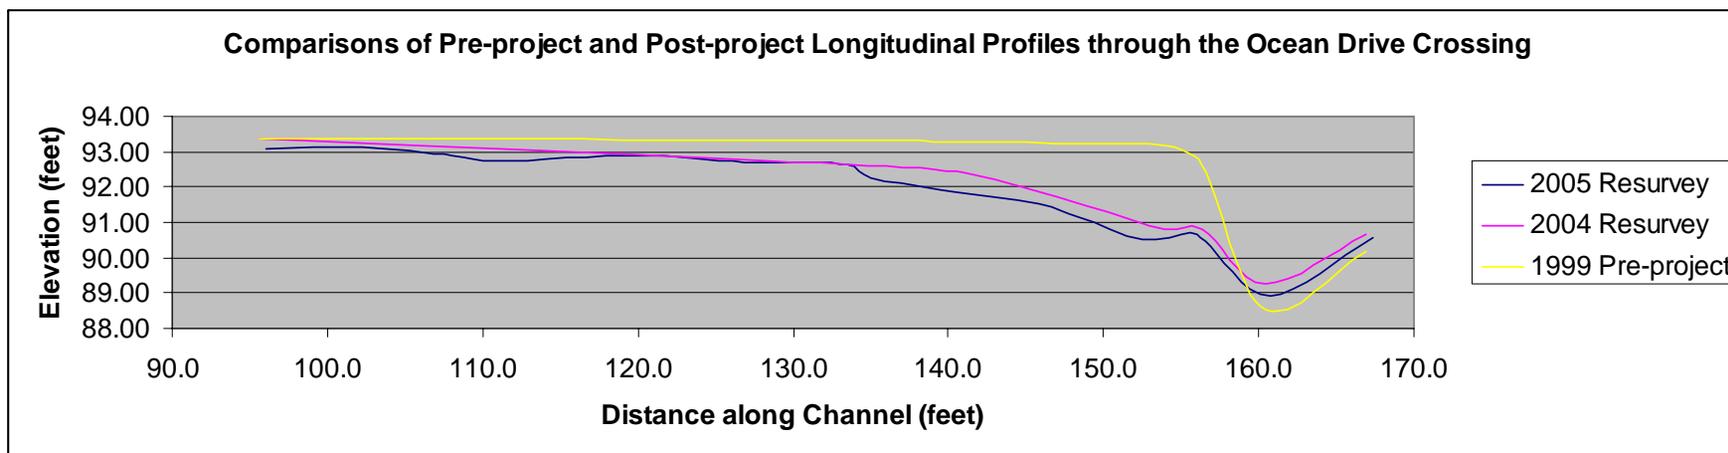
The overall slope through the crossing (from inlet to outlet) was 3.98 % (4.25% for 2004 survey) and the slope of the steeper break-in-slope along the lower 22.1 feet of the crossing was 7.19% (8.33% for 2004 survey). Although this lower section of the new crossing is still fairly steep, the roughness of the cobbles and small boulders may likely reduce velocities and still allow fish passage. Also, it appears that subsequent winter storms have caused a minor re-grade of the substrate through the crossing and lessened the slope of this steeper section (Figure 4). Comparison of the 2004 and 2005 longitudinal profiles also revealed an overall down-cutting of the stream bed elevation from the exposed bedrock located 30 feet upstream of Ocean Drive to the bedrock TWC of the outlet pool (Figure 4). Comparison of the two post-project longitudinal profiles with the pre-project profile documents the elimination of the extremely perched outlet that was the main impediment to fish migration at the pre-project culvert (Figure 5).

Figure 5. Comparisons of longitudinal profiles of Digger Creek through the Ocean Drive; pre-project survey from 1999 through the perched arch culvert and post-project surveys from 2004 and 2005 through the open-bottom arch.
