**Culvert Monitoring  
 Skinner Creek Culvert  
 Culvert #1237, Road 3462  
 Skinner Creek, Tributary to Canal Creek  
 South Zone (Waldport Ranger District), Siuslaw National Forest  
 June 17, 2004**

**Comparison of Culvert and Stream Dimensions before and after retrofit**

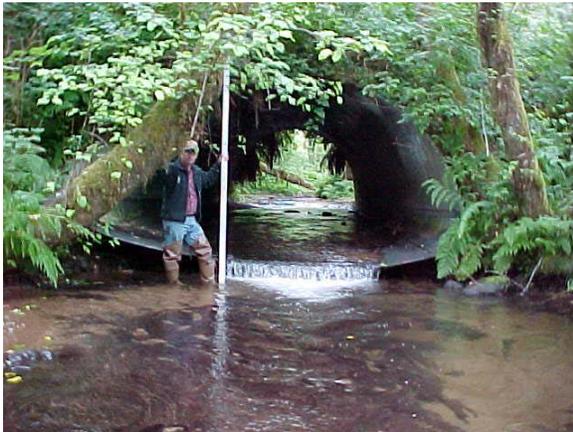
The width of the existing culvert is 64% of the stream’s bankful width. However, the culvert is in good shape, and the future of this road segment is uncertain. It may be closed at a later date. There was a drop of one foot at the culvert outlet, and the stream was downcut and scoured to bedrock between the outlet and the confluence of the stream with Canal Creek, a distance of 140 feet. The upstream channel was in good shape, and has a pool-riffle morphology (Figure 1).

Figure 1. Outlet in Summer 2000 before retrofit

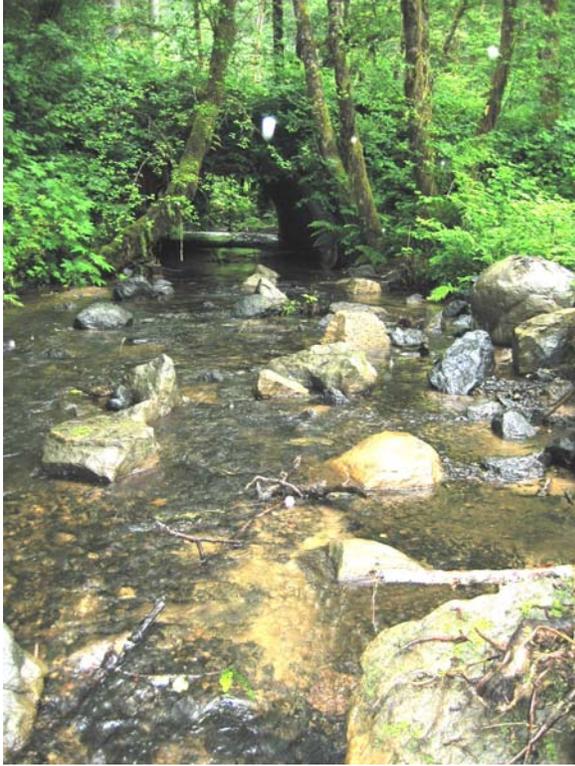
“Retrofitting” the culvert was done in August-September, 2003. The streambed was built up downstream from the culvert outlet for a distance of approximately 100 feet using pit-run angular basalt rock from a quarry (3-6 inches in diameter), and randomly placed boulders. The result was a streambed that looked like a lag deposit from a debris torrent. After one winter, the streambed was still in place, and sediment was being deposited in the lee of the boulders. The streambed aggraded 0.5 feet through the culvert. The streambed below the culvert remained at the same gradient of 1.18% (Figures 2-4).

Figure 2. Looking upstream at the culvert outlet after the streambed was built up with angular basalt cobbles and boulders.

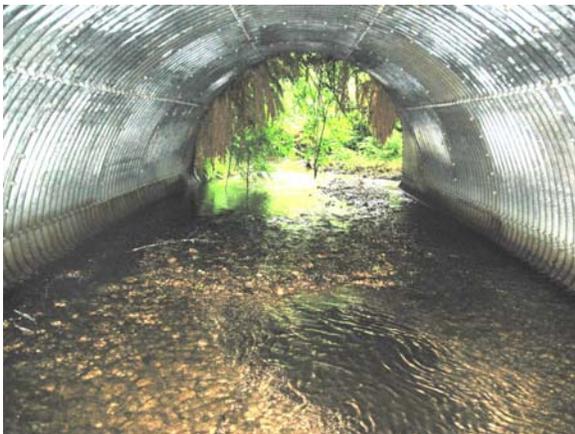
No material was added to the streambed inside the culvert. After the streambed was built up downstream of the culvert, sands and gravels were deposited inside the culvert to a depth of at least 0.5 feet. (Figure 3, Figure 5).

Figure 3. Looking downstream through the

culvert at the outlet. Note the sediment that is aggrading on the left side of the photo.

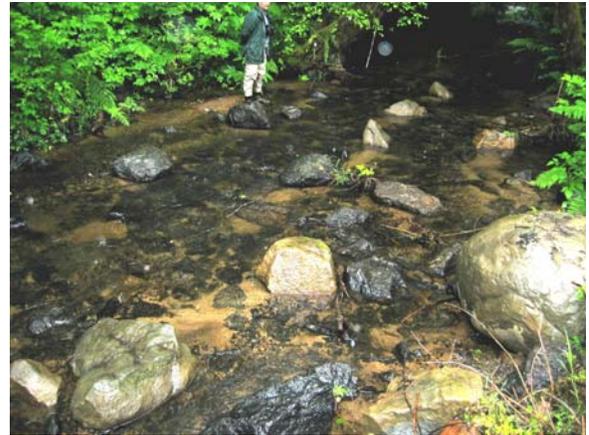
Figure 4. Closer view of the built-up streambed below the culvert outlet. Note the lighter colored fine-grained sediment that is accumulating downstream of the boulders.

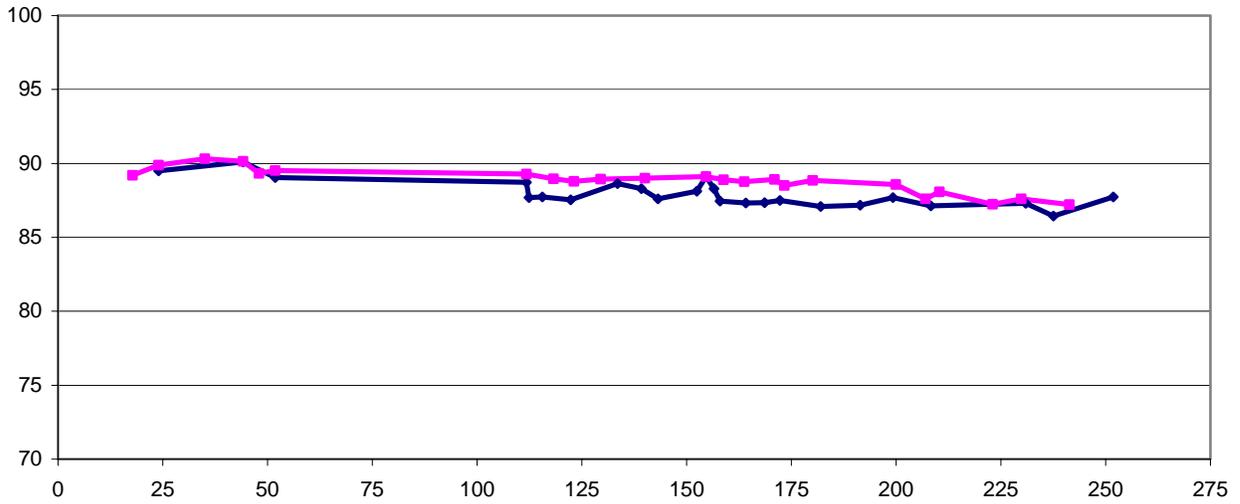
**Skinner Creek Longitudinal Profile before and after adding streambed material**

After one winter, the streambed downstream from the culvert appears stable. No erosion from winter flows was noticed. There was no change upstream from the culvert (Figures 5 and 6).

Figure 5. Longitudinal profile of the stream thalweg before the streambed was built up (lower blue line) and the profile after the coarse sediment and boulders were added (higher pink line). Streamflow is from left to right. Scale is in feet.

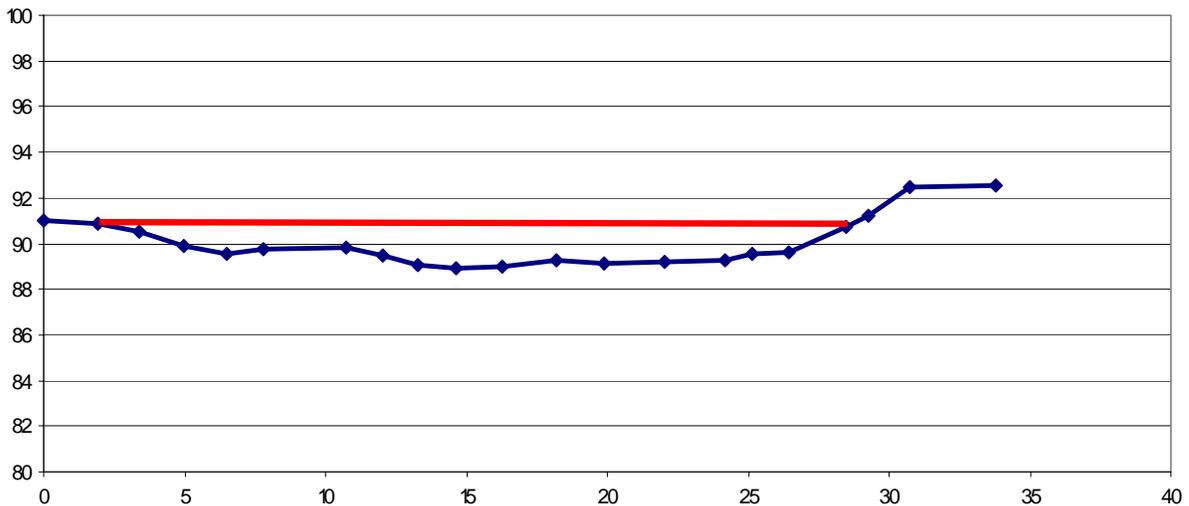
**Skinner Creek Culvert Cross-Section below Culvert, across added sediment**

Figure 6. Cross-section across the added sediment in the streambed below the culvert. The red line represents the bankful height and width of the channel.
