Project Monitoring Summary

Project Name:	Third Fork Culvert Replacement Project (TFCR)
Date of Site Visit:	8/13/2005 and 8/17/2005
People Present:	Melissa Yenke and Trisha Giambra
Weather Conditions:	Sunny and Warm

Wilson Creek Culvert

Purpose of Visit: Post Project Photo Monitoring

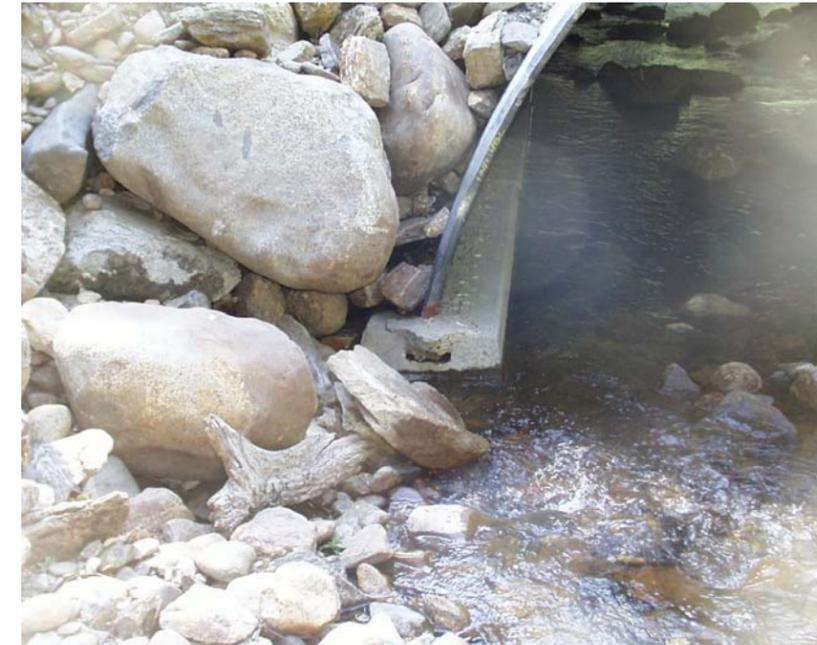
- Outlet pool has filled in.
- At the inlet of the pipe there material is depositing on the right bank and the thalweg of the stream is currently hitting the end of the footer on the left side of the inlet. (Note: On August 29, 2005 the road crew moved some large boulders in front of the left footer to direct flow away from the footer.) See Figures 14 & 15

Figure 14 – Wilson Creek Culvert Inlet (Left Footer) August 13, 2005.

- Seeding and mulching bare areas up and downstream of pipe. Possible Willow Plantings.
- Utilize Road Crew to complete some streambank work on upstream side of culvert.

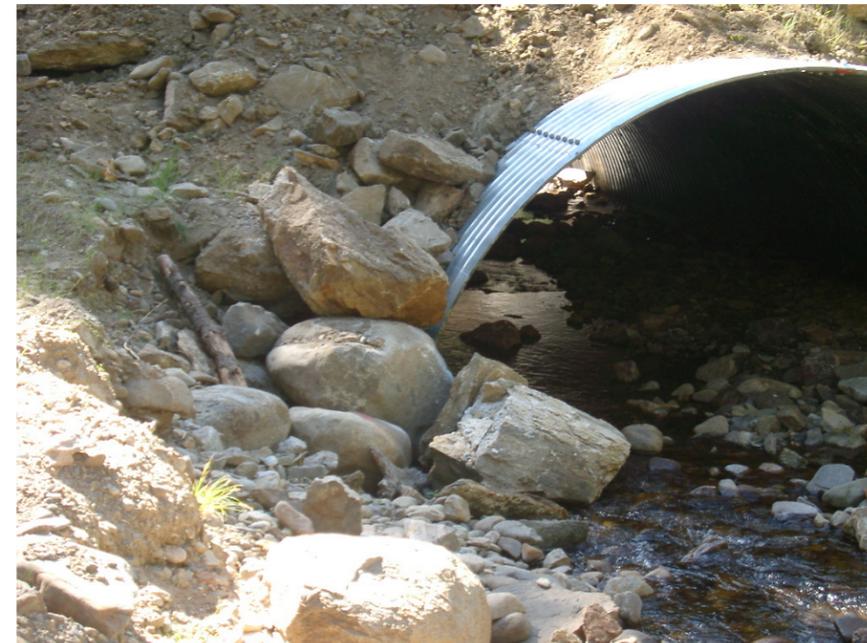
Figure 15 – Wilson Creek Culvert (Left Footer) August 29, 2005.

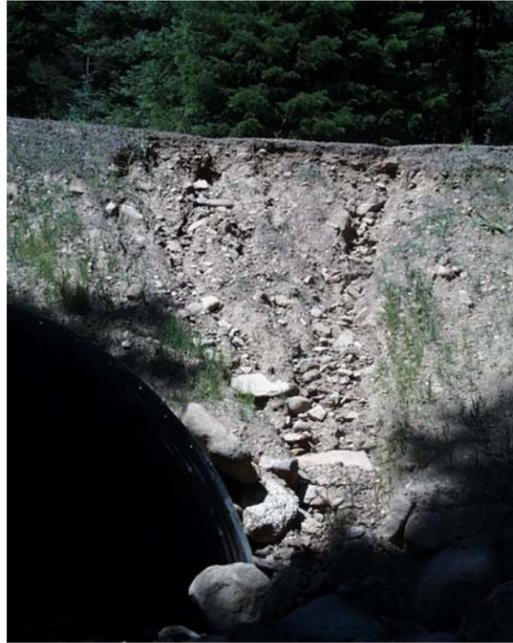
- There is active erosion with direct delivery to Wilson Creek from the fill over the pipe on both the upstream and downstream sides. (Note: On August 29, 2005 the road crew added rock to the fill above the culvert to stop erosion of the fill.) See Figures 16, 17, & 18.

Figure 16 – Example of Fillslope Erosion on Downstream Side of Culvert (August 13, 2005).

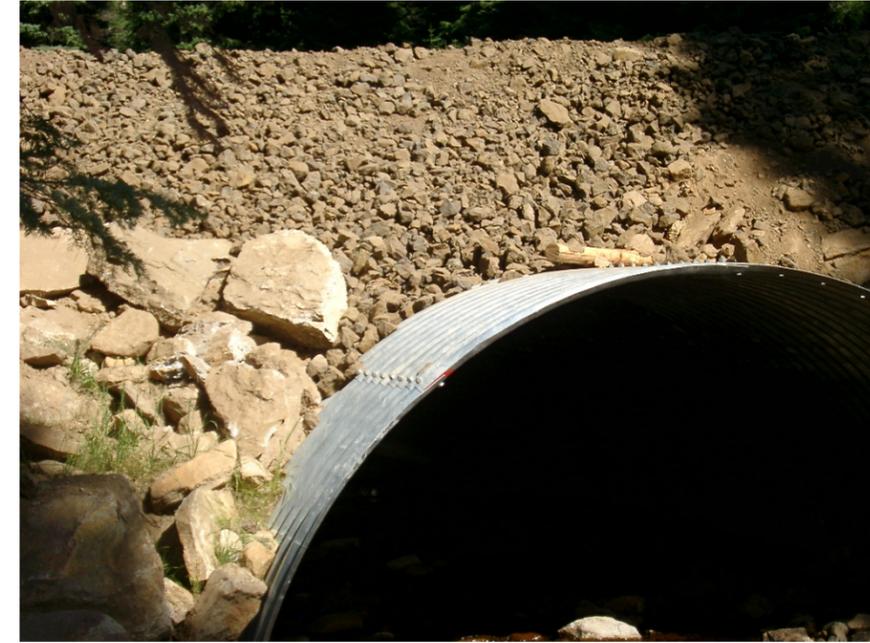
Figure 18 – Example of Rock Placed on Fillslope to reduce erosion (August 29, 2005).

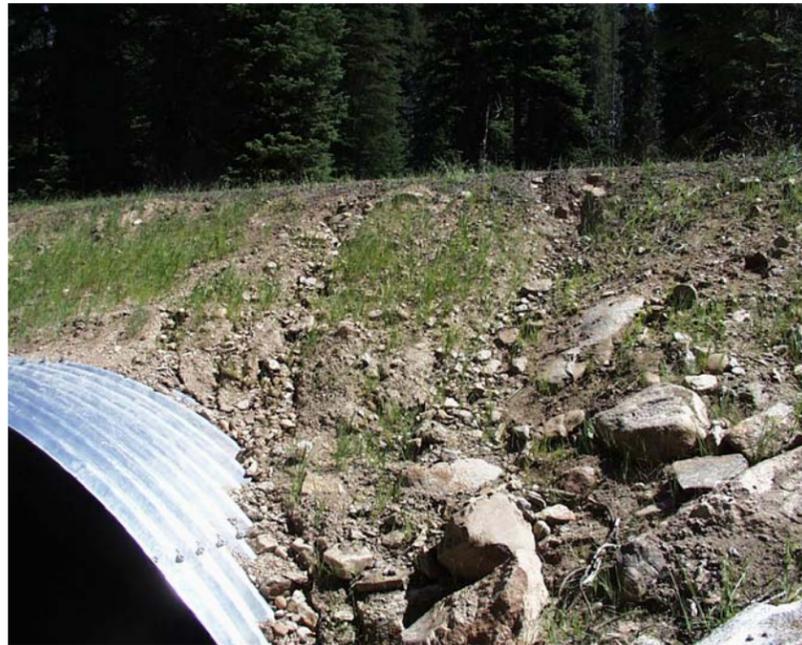
Figure 17 – Example of Fillslope Erosion on Upstream Side of Culvert (August 13, 2005)

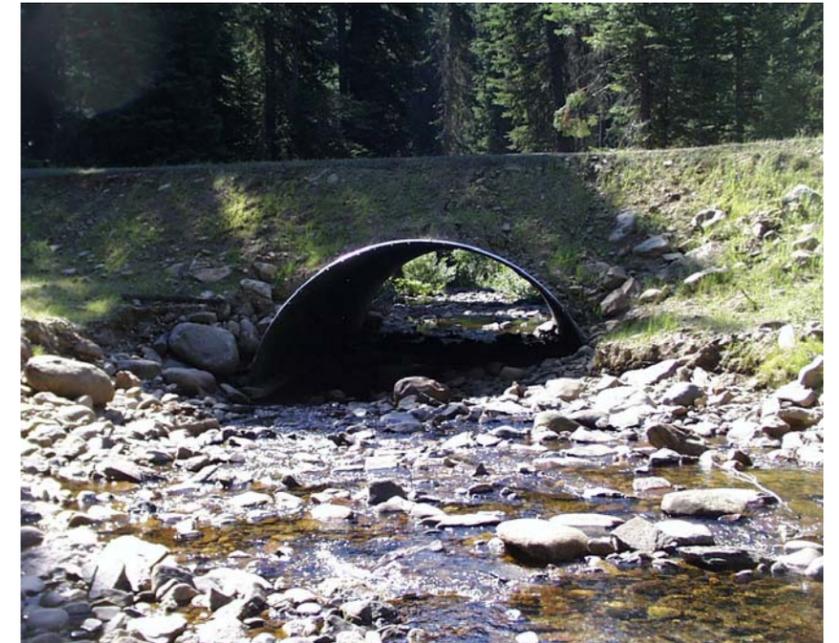
Figure 23 – Wilson Creek Culvert Inlet August 2005.

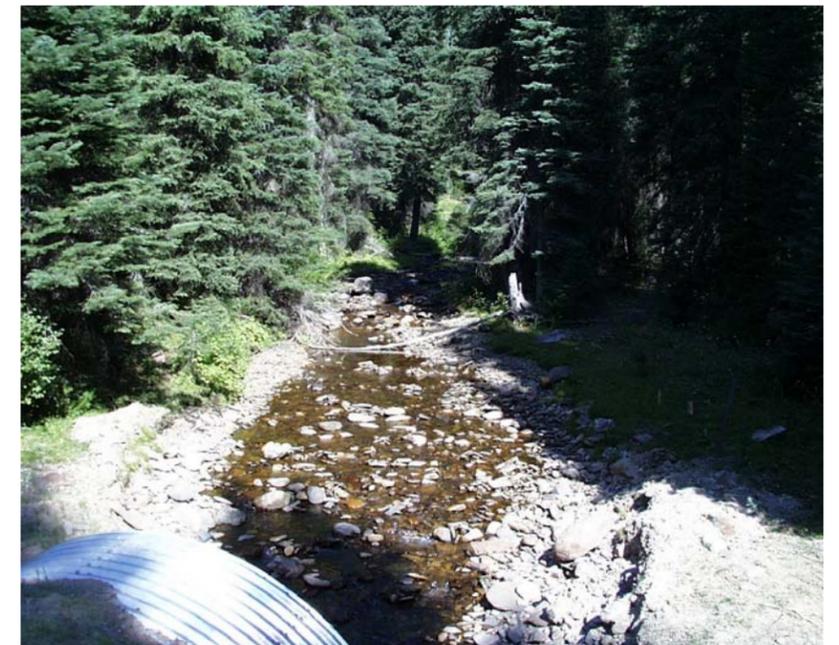
Figure 24 – Wilson Creek Upstream of Culvert August 2005.

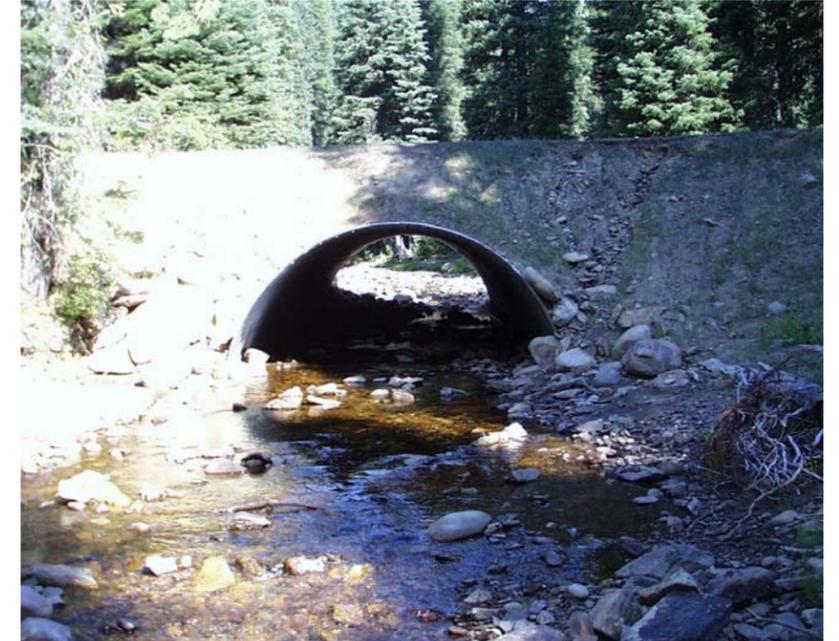
Figure 29 – Wilson Creek Culvert Outlet August 2005.

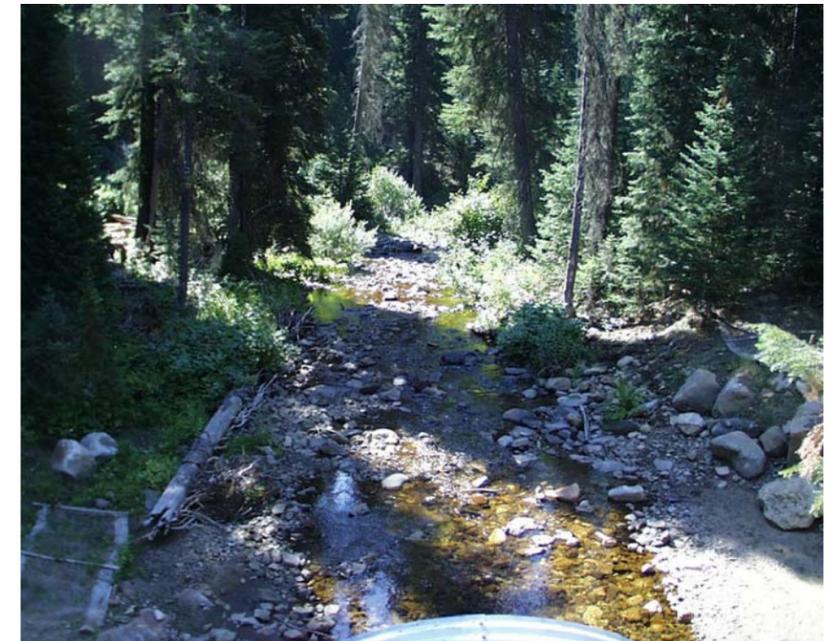
Figure 30 – Wilson Creek Downstream of Culvert August 2005.
