Peacock Creek Pool and Weir Fishway

THE DESIGN SOLUTION – VORTEX POOL and WEIR FISHWAY

FINAL DESIGN – PLAN VIEW

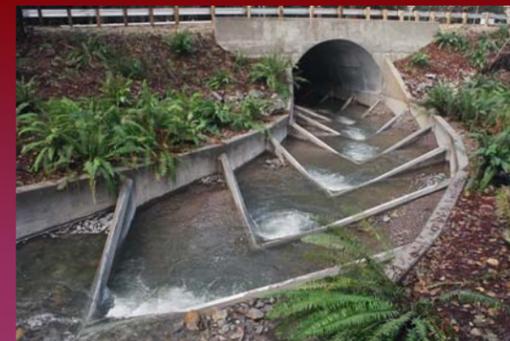
Looking downstream at culvert inlet (fishway exit). Vortex weirs with 8 inch drops concentrate flow to create scoured pools. This weir shape increases the ranges of flows for fish passage, and improves jump conditions for juvenile fish.

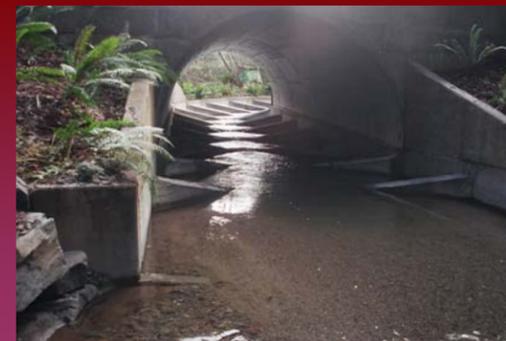
Looking upstream at culvert outlet (fishway entrance). The last two weirs are backwatered to provide a swim in entrance at low flows and energy dissipation at high flows.

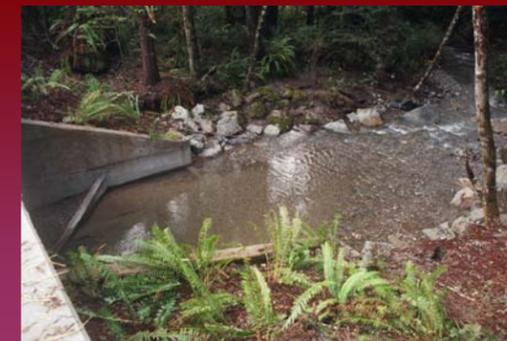
Looking downstream at outlet. A boulder weir was installed to provide tailwater control and maintain the swim in entrance and to protect the downstream channel from the erosion of high flows.

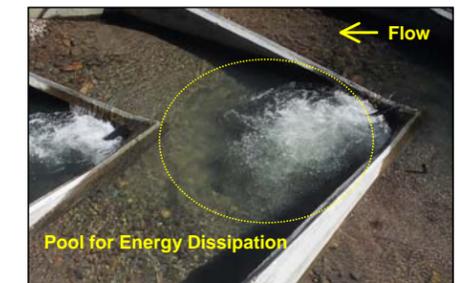
Pool and weir fishways operate in **Plunging Flow** regime during fish passage flows and in streaming flow at higher discharges

The **Energy Dissipation Factor** is a measure of turbulence in each pool. EDF values greater than 4 lb/ft²-s indicate flow may be turbulent enough to disorient and fatigue fish.

The pool must be deep enough to provide adequate volume to dissipate energy from the plunge.
