MEMO

**Re:** **As-Built Project Information**  
Jalama Road Fish Passage Enhancement Project  
Salsipuedes Creek, California

This memo has been prepared to present the as-built project drawings and photographs for the Jalama Road Fish Passage Enhancement Project and monitoring data collected in 2004 following project construction. The objective of the project is to enhance passage for steelhead/rainbow trout immediately downstream of the Jalama Road bridge crossing along Salsipuedes Creek (Figure 1). Prior to the project, a concrete/bedrock grade control structure, which is situated approximately 70 feet downstream of the Jalama Road bridge crossing, acted as a physical barrier to steelhead/rainbow trout passage under low flow conditions due to the difference in height between the water surface in the downstream pool and the crest of the structure which is approximately 5 feet. The project enhances passage over the structure through the construction of 3 step-pools in the bedrock outcrop situated adjacent to the grade control structure along the right streambank (facing downstream). The step-pools provide a passage corridor for steelhead/rainbow trout by reducing the existing ver

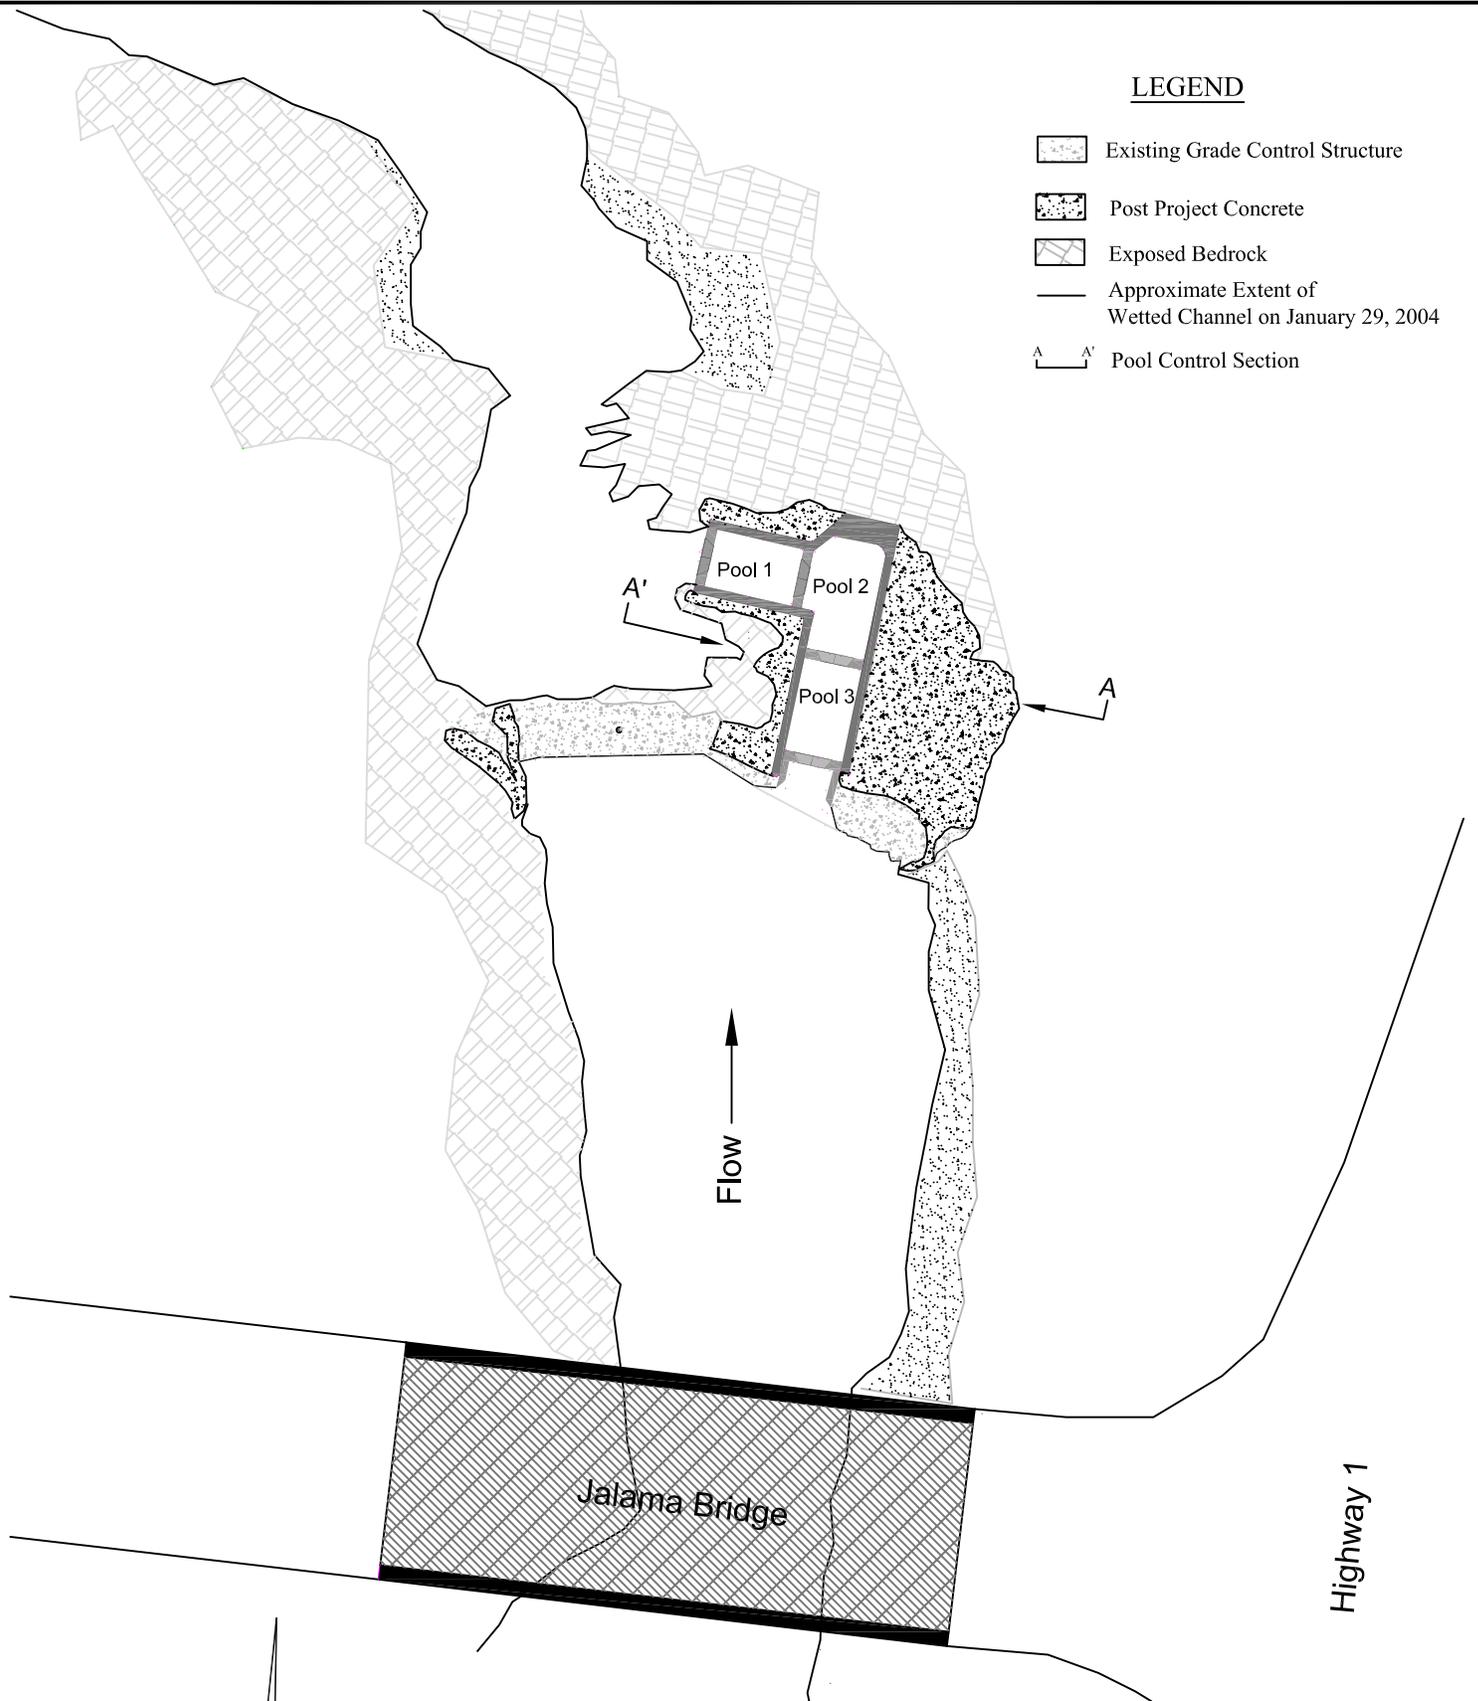
**FIGURE 2  
AS-BUILT  
SITE PLAN**

\*Note: Elevations are tied to a site-specific datum and coordinate system established by ENTRIX

The final pool dimensions and depths are provided in Table 1 and a pool control weir rating table is presented in Table 2. The as-built project layout and sections are presented in Figures 2 and 3. Photographs of the project including pre- and post-project photos are presented in Attachment A.

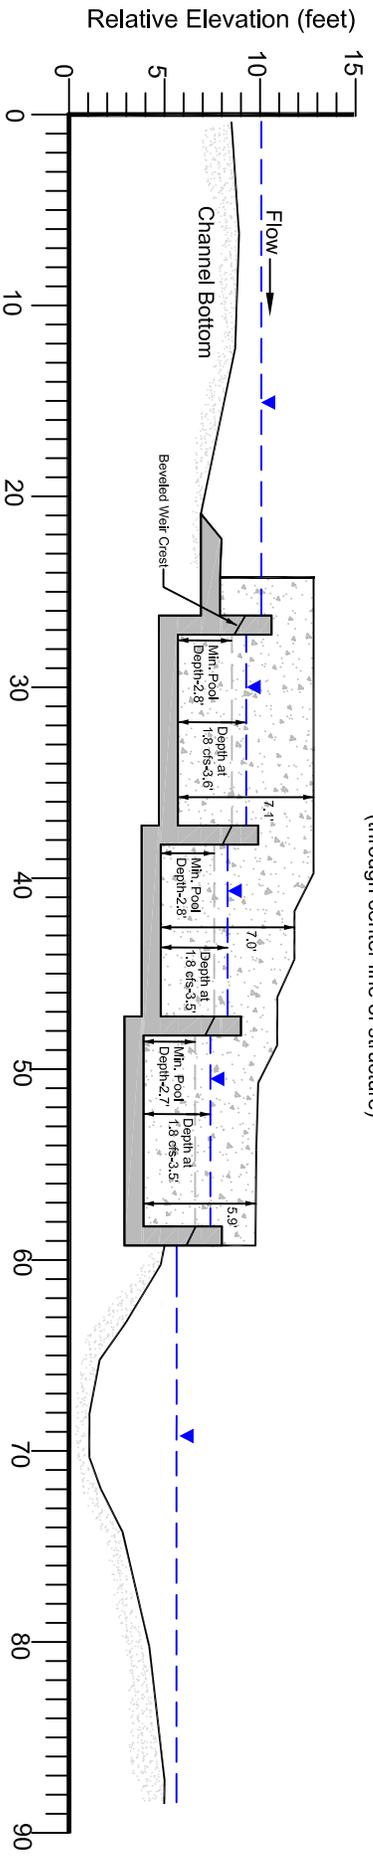
**FIGURE 3**  
**LONGITUDINAL PROFILE AND**  
**POOL CONTROL SECTION**

**Longitudinal Profile**  
(through center line of structure)

Note: Water surface elevations at the time of the survey on January 29, 2004. Streamflow at the time of the survey was 1.80 cfs based on gage readings at USGS Gage #11132500.

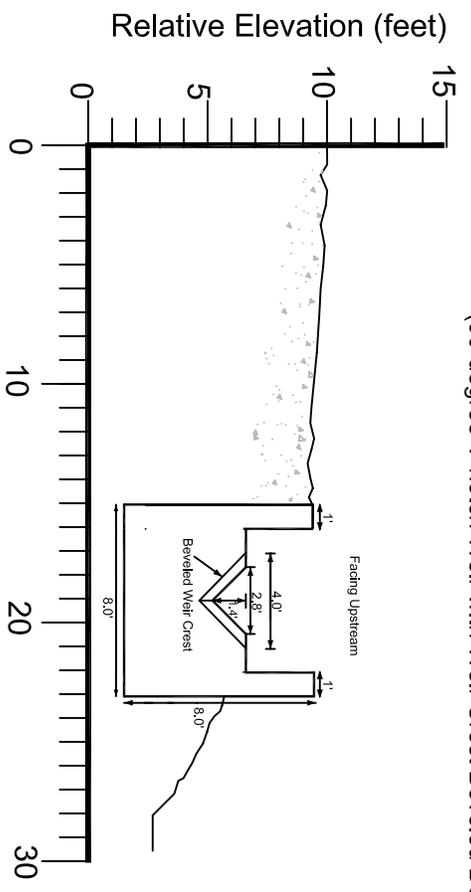
**Typical Pool Control Section**  
(90-degree V-notch Weir with Weir Crest Beveled Downstream)

<b>Stage Above Weir Crest (feet)</b>	<b>Estimated Flow* (cfs)</b>
0.1	0.0
0.2	0.0
0.3	0.1
0.4	0.3
0.5	0.4
0.6	0.7
0.7	1.0
0.8	1.4
0.9	1.9
1.0	2.5
1.1	3.2
1.2	3.9
1.3	4.8
1.4	5.7
1.5	6.7
1.6	8.2
1.7	10
1.8	12
1.9	14
2.0	16
2.1	19
2.2	21
2.3	24
2.4	27
2.5	30
2.6	33
2.7	36
2.8	39
2.9	42
3.0	46
3.1	49
3.2	53
3.3	57
3.4	60

\* Estimated flows for stages between 0 and 1.4 feet were calculated using the standard 90-degree V-notch weir formula and estimated flows for stages between 1.4 and 3.4 feet were calculated using a standard compound weir formula.

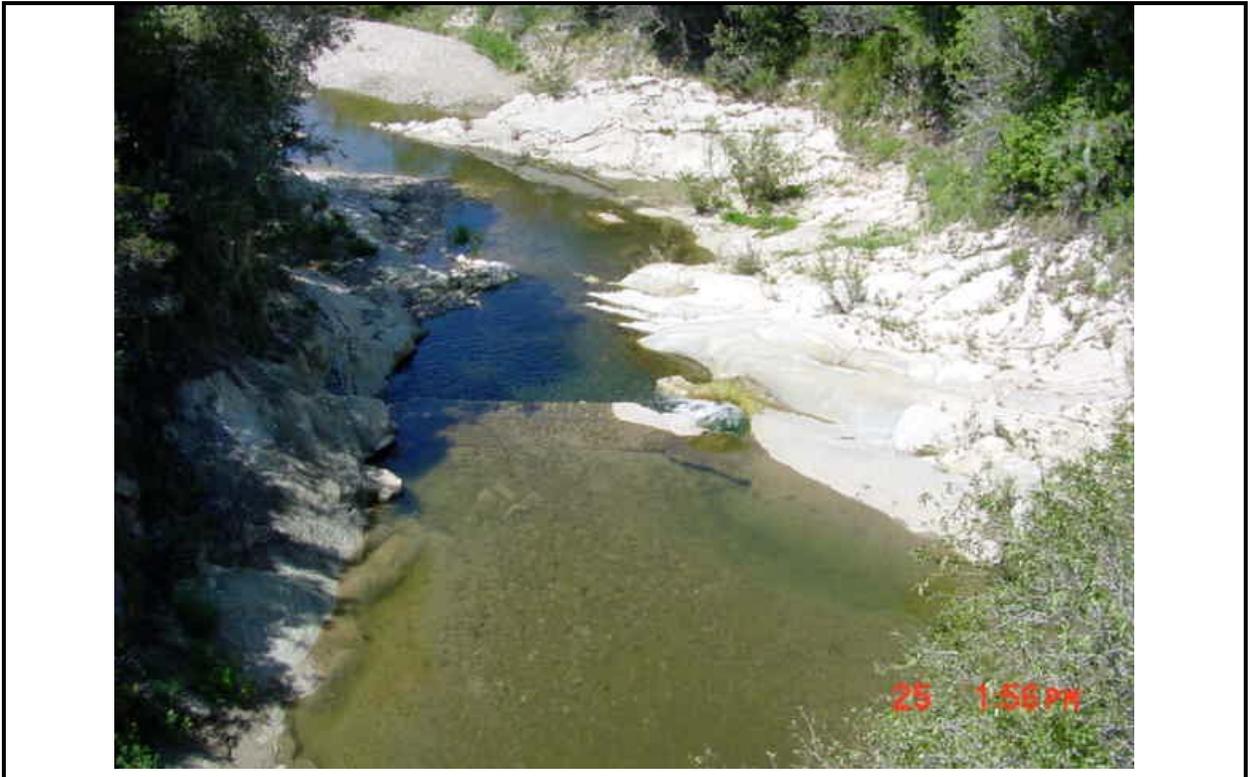
**Photograph 1** – Project site in April 2003 prior to project construction (facing downstream from the Jalama Road bridge crossing).

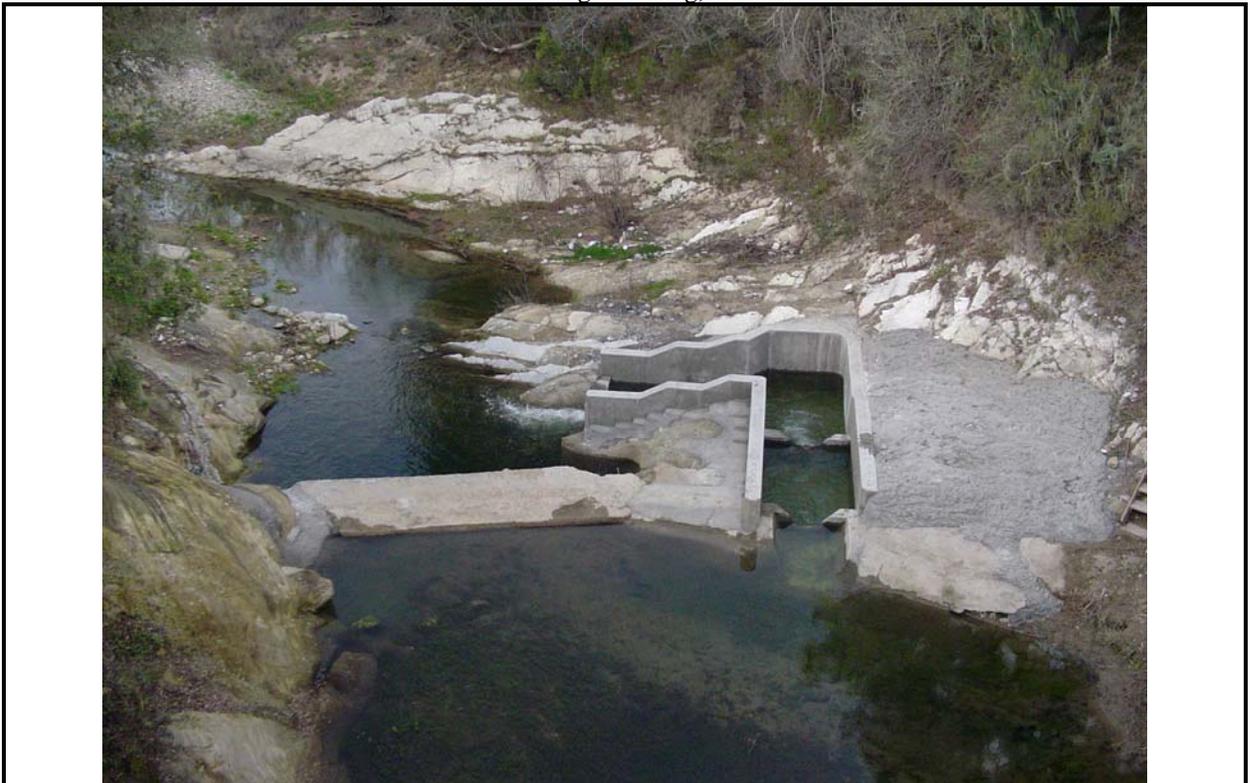
**Photograph 2** – Project site on January 29, 2004 following project construction (facing downstream from the Jalama Road bridge crossing).

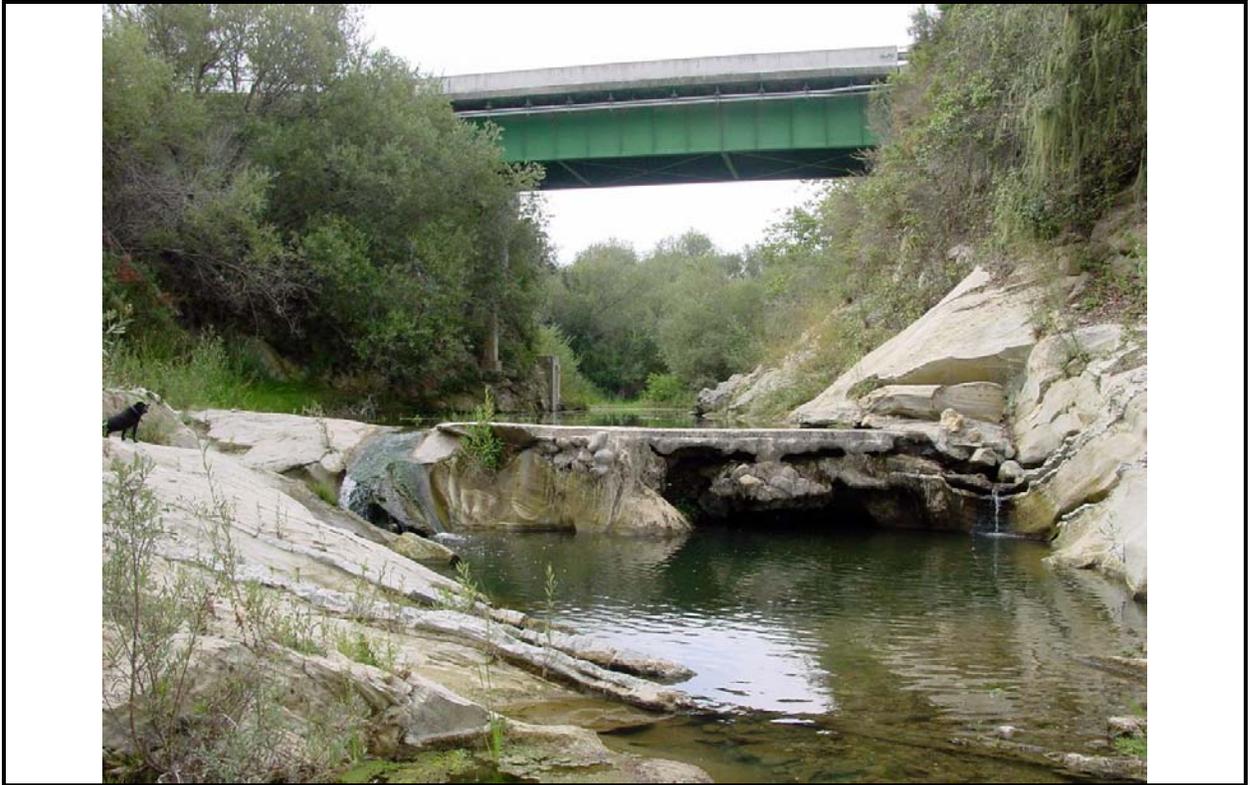
**Photograph 3** – Project site in August 2003 prior to project construction (facing upstream toward the Jalama Road bridge crossing).

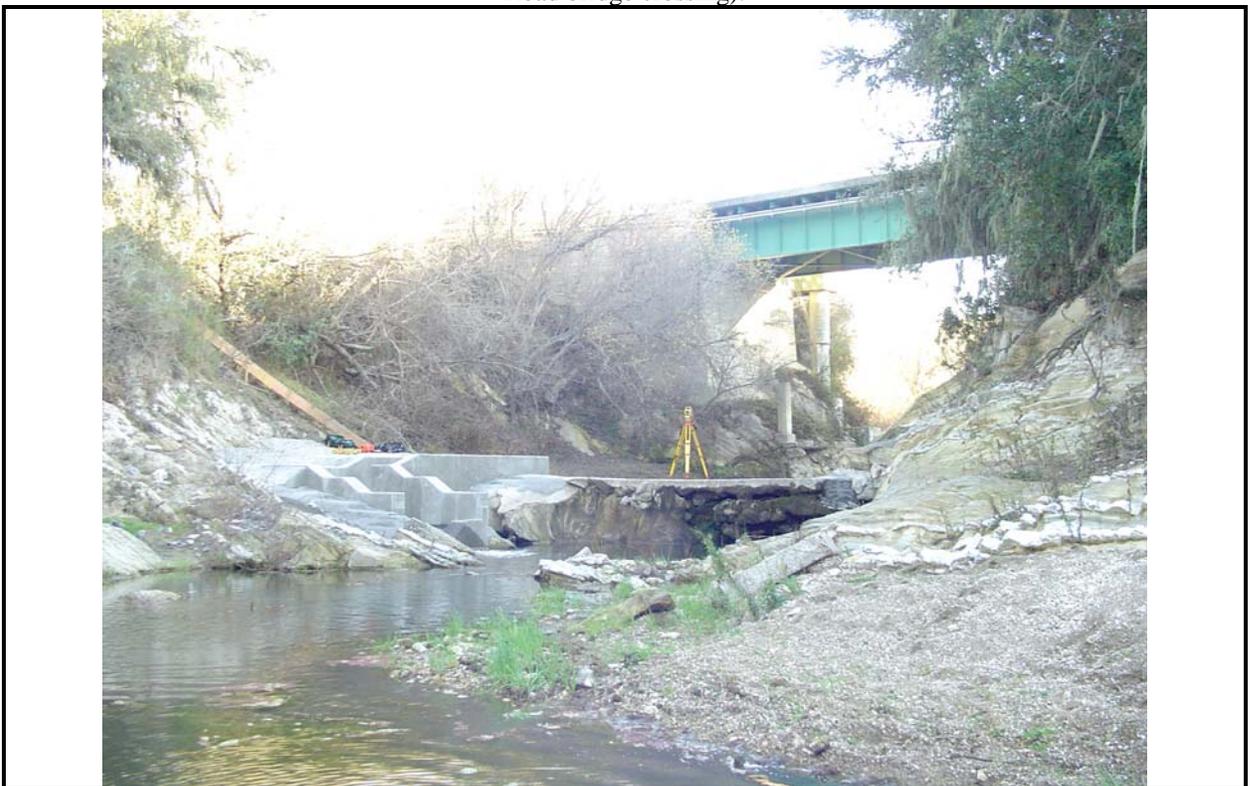
**Photograph 4** – Project site in January 2004 following project construction (facing upstream toward the Jalama Road bridge crossing).

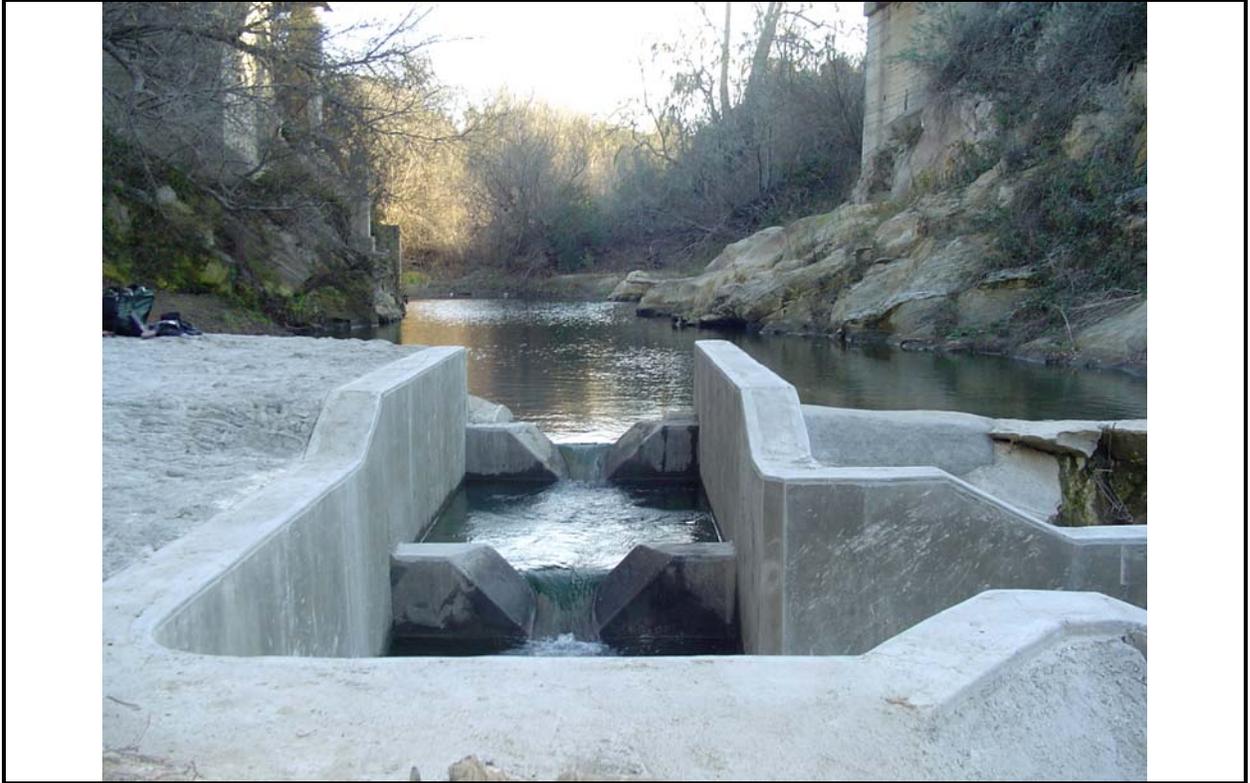
**Photograph 5** – Facing upstream toward the exit of the structure at a flow of approximately 1.80 cfs.

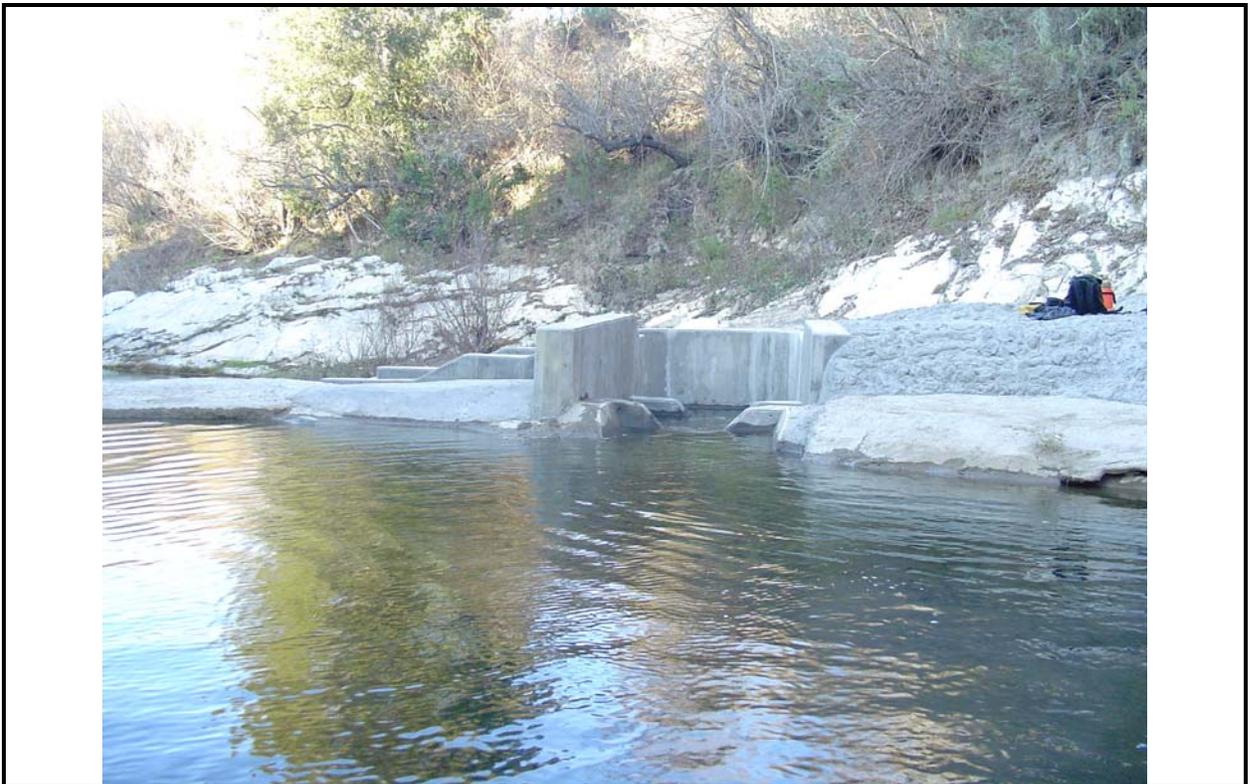
**Photograph 6** – Facing downstream toward the exit of the structure at a flow of approximately 1.80 cfs.

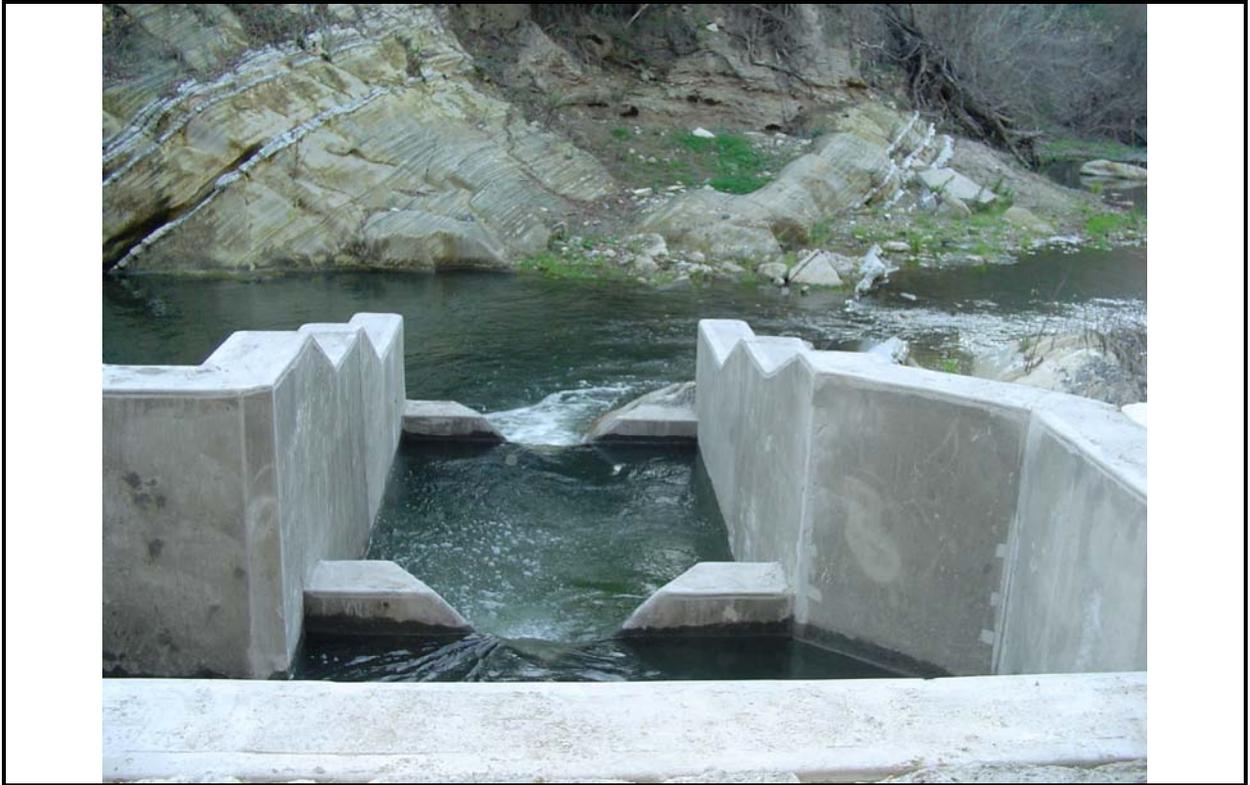
**Photograph 7** – Facing downstream toward the entrance of the structure at a flow of approximately 1.80 cfs.

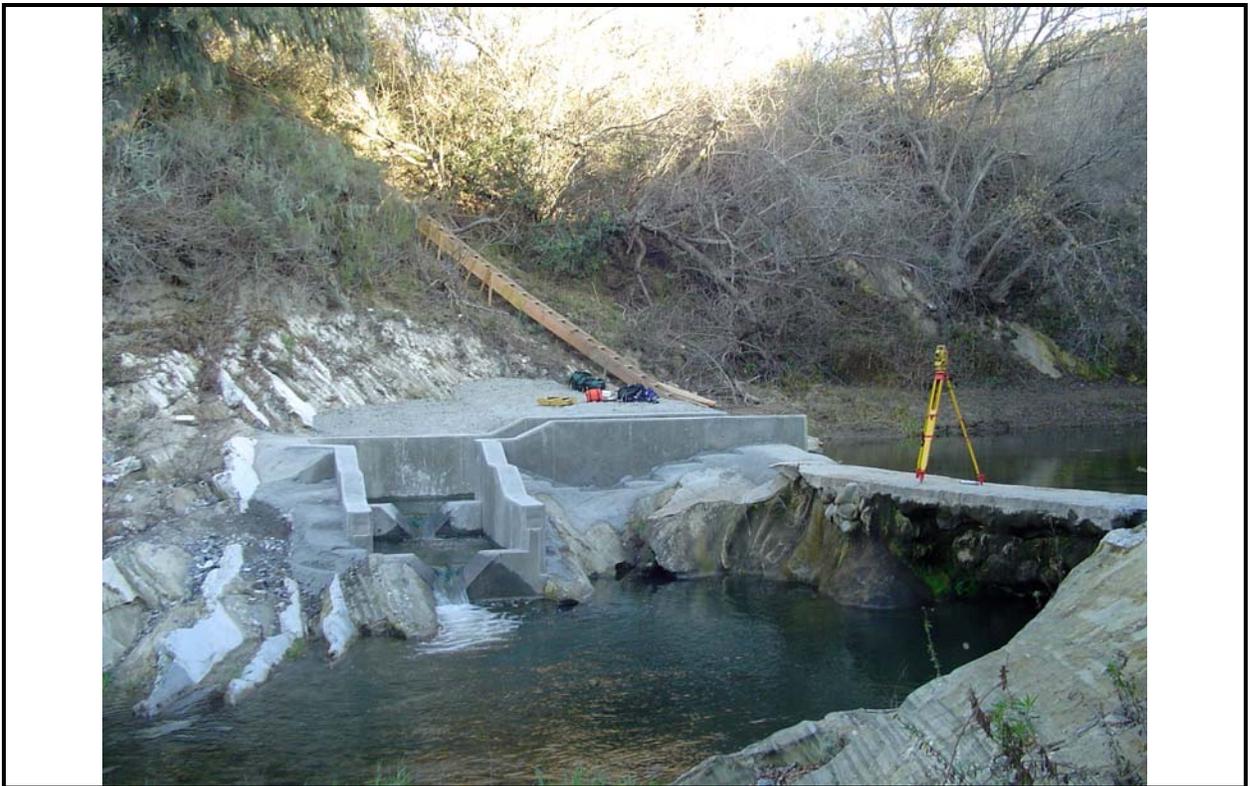
**Photograph 8** – Facing upstream toward the entrance of the structure at a flow of approximately 1.80 cfs.

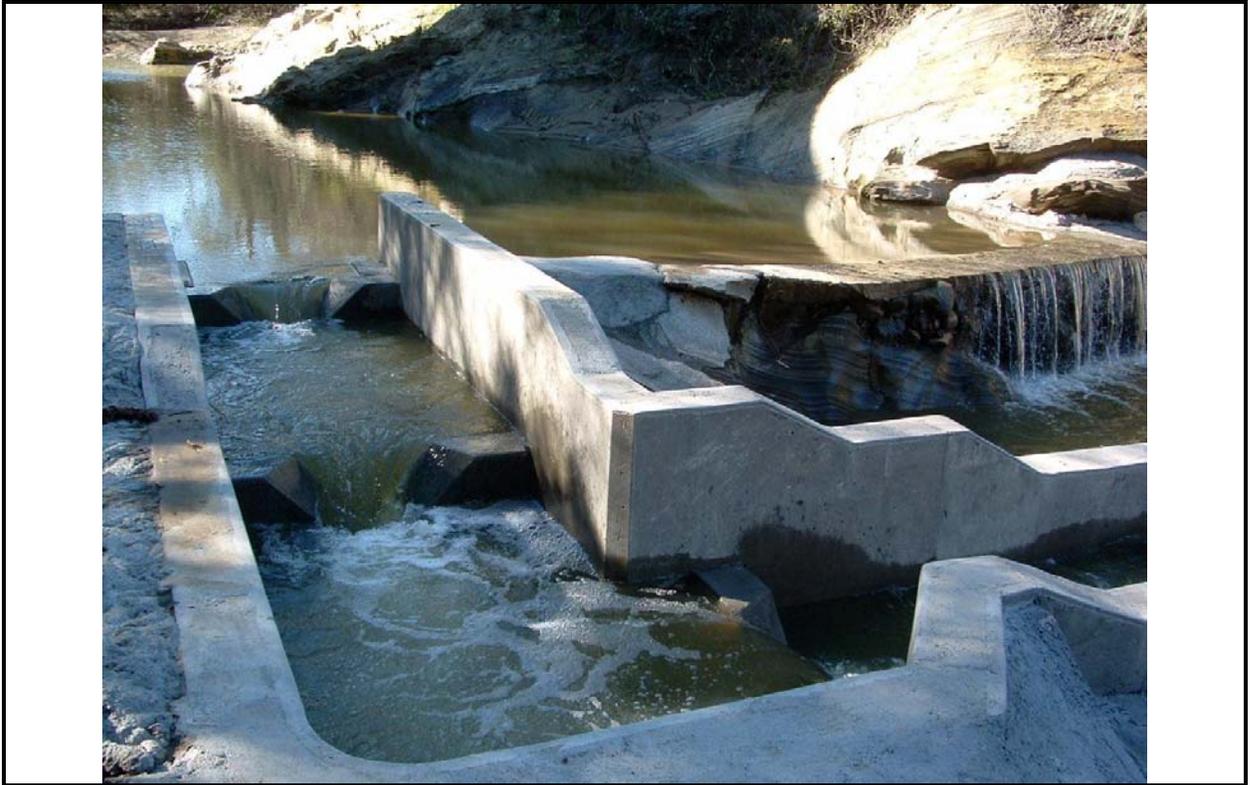
**Photograph 9** – Facing upstream toward the exit of the structure at a flow of approximately 7.30 cfs.

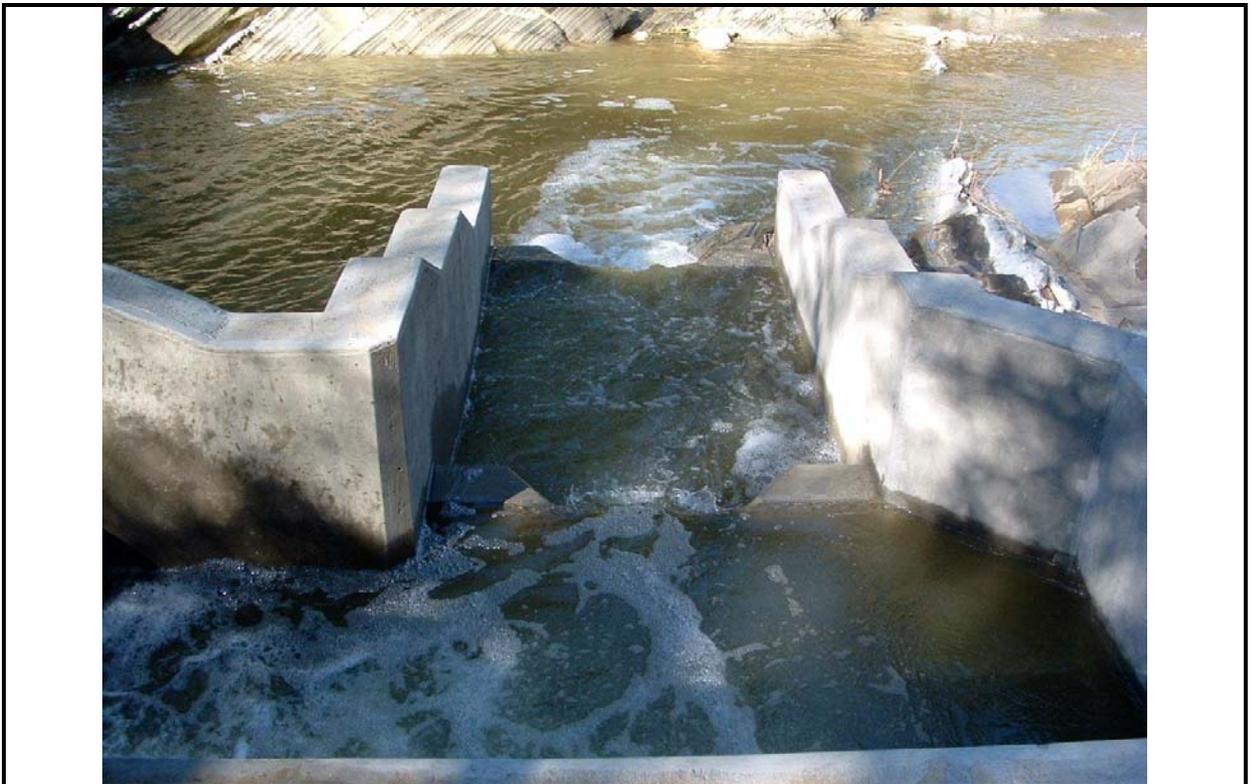
**Photograph 10** – Facing downstream toward the entrance of the structure at a flow of approximately 7.30 cfs.
