FISH PASSAGE THROUGH POPLAR GROVE CREEK

FINAL REPORT

February 1987

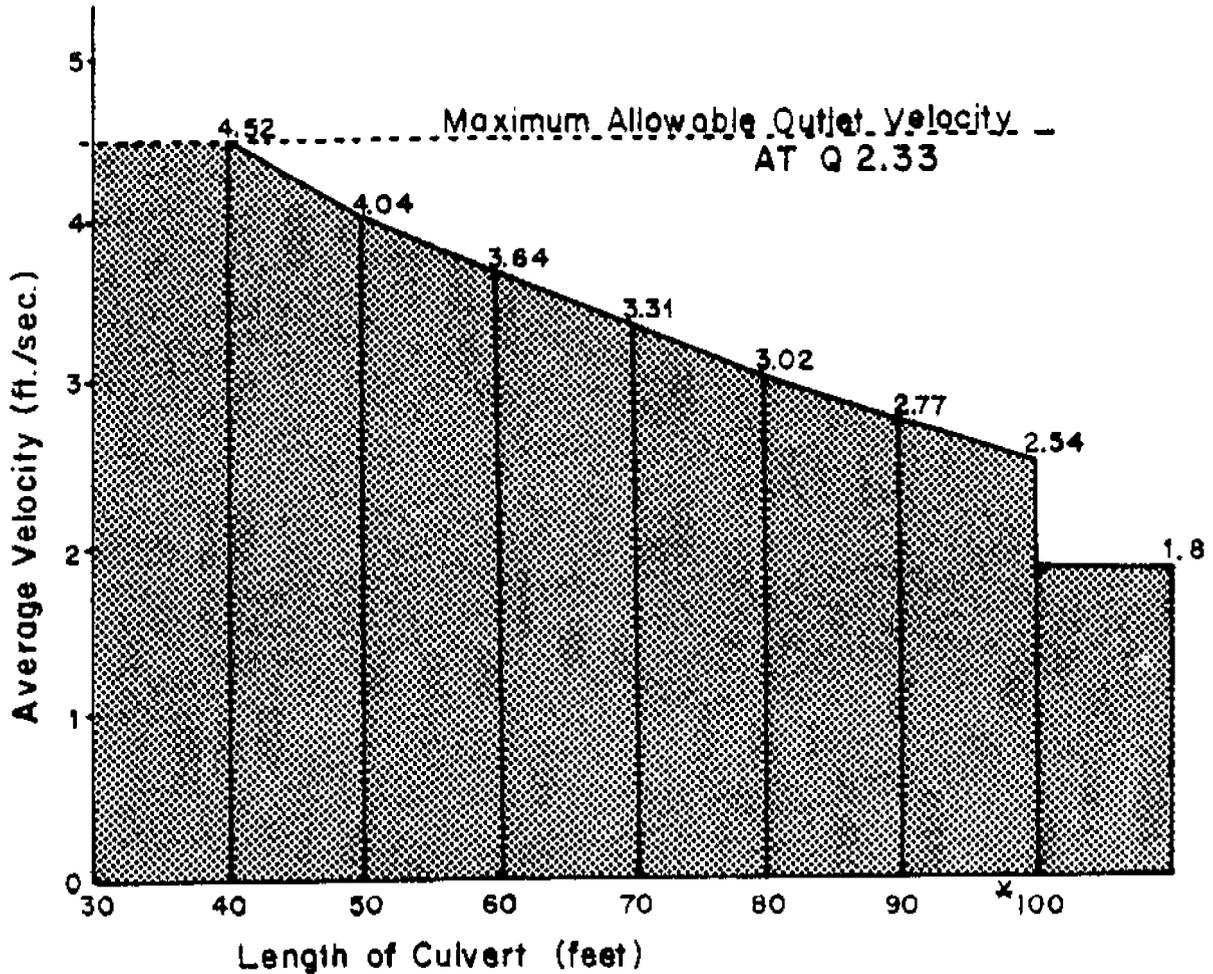
FIGURE-2: ALASKA DEPARTMENT OF FISH AND GAME
FISH PASSAGE CRITERIA

ADF&G ASSUMES ADHERENCE TO THESE VELOCITIES WILL ALLOW 75% OF 9.5 INCH GRAYLING TO PASS THE CULVERT AT A WATER TEMPERATURE OF 2.8° C.

*1.80 ft./sec. for culverts larger than 100 feet

The Poplar Grove Creek culvert is 110-foot long (skewed to the road crossing at about 45 degrees), five feet in diameter and constructed of corrugated metal. It has been in place since 1953. The outlet is perched approximately one foot above the stream bed. In the middle of the culvert, subsiding road materials and traffic load have depressed the top of the pipe (Figure 5). The culvert is positioned on about a 0.5% slope, and no stream-bed material was present along the culvert's bottom during the field study. A 60-foot by 120-foot scour pool exists at the culvert outlet. The pool depth ranges from about 2 to 5 feet and is a popular fishing spot for local residents. The ADF&G fish passage criterion requires a maximum average outlet velocity of 1.8 fps during a $Q_{2.33}$ for a culvert of this length (Figure 2) for Arctic grayling (Logan, 198).

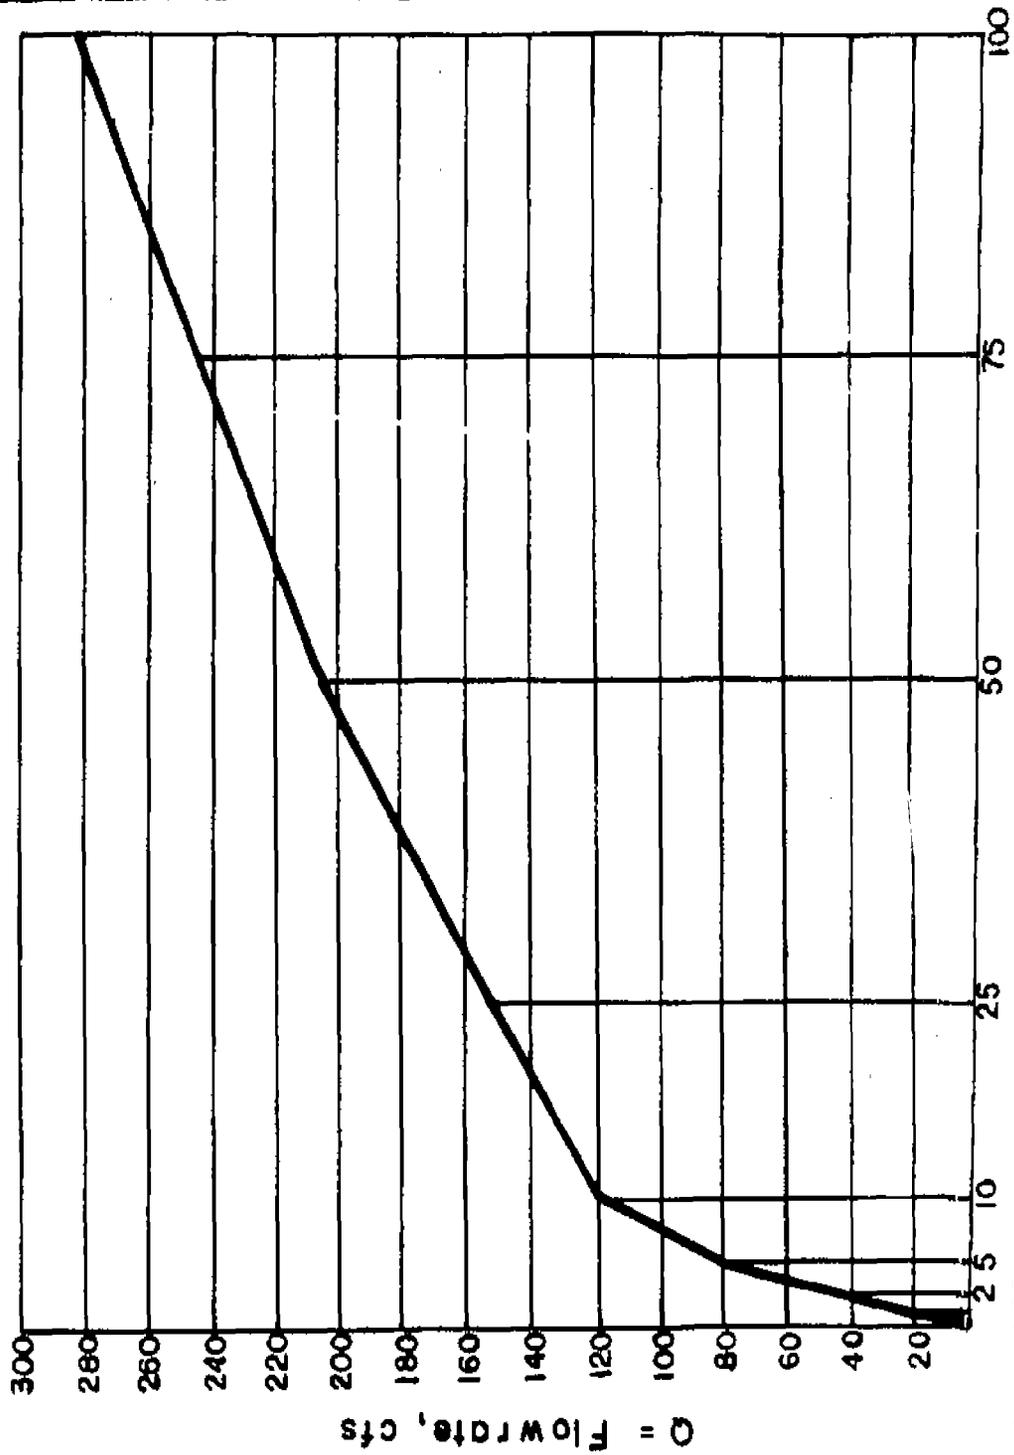
FIGURE 4 Expected Frequency of Occurrence in Years

CALCULATED MAGNITUDE AND FREQUENCY OF PEAK DISCHARGE

Figure 4 shows the calculated magnitude and frequency of peak discharges for Poplar Grove Creek including only the 12 square miles of drainage above the highway. In comparing the peak discharge that occurred during the study period with the graph (Figure 4), 139.1 cfs should occur about every 20 years (Q_{20}). Therefore, the study took place during an unusually high peak discharge. MacPhee and Watts (1976) recorded discharge rates for Poplar Grove Creek at the concrete abutment facility which was located approximately one mile downstream of the

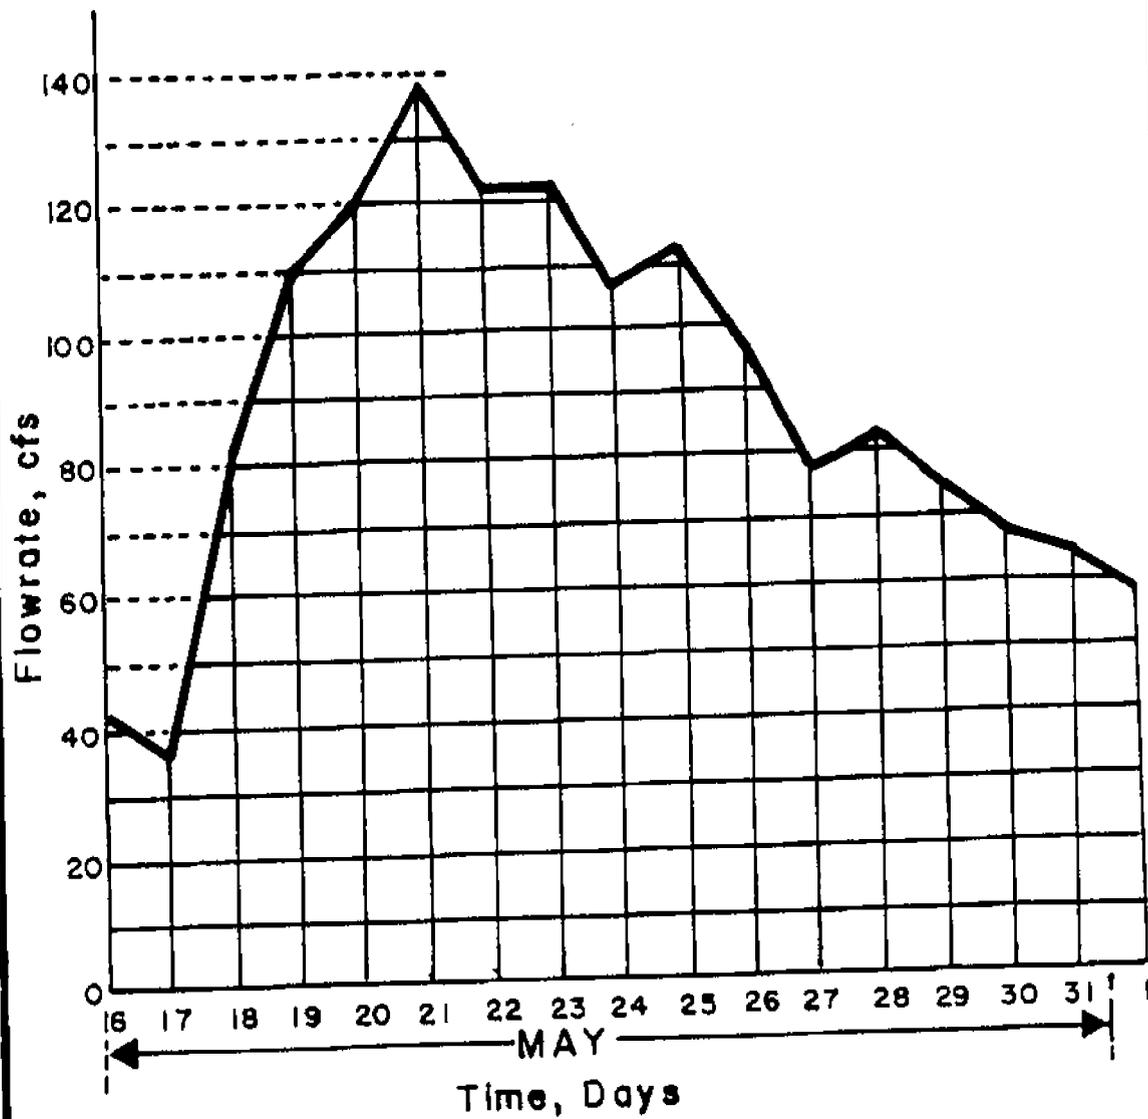
FIGURE 10
 1985 DAILY DISCHARGE RATES (cfs)
 AT POPLAR GROVE CREEK HIGHWAY
 CROSSING

to excessive culvert outlet velocities. Figure 10 displays the daily discharge rates through the culvert. The flow peaked at 139 cubic feet/second (cfs) on May 21, at which time the velocity was estimated to be about 11 fps (see Figure 12). Therefore, the initial fish arriving at the culvert corresponded to the decrease of the flow rate as the hydrograph declined beginning May 21.

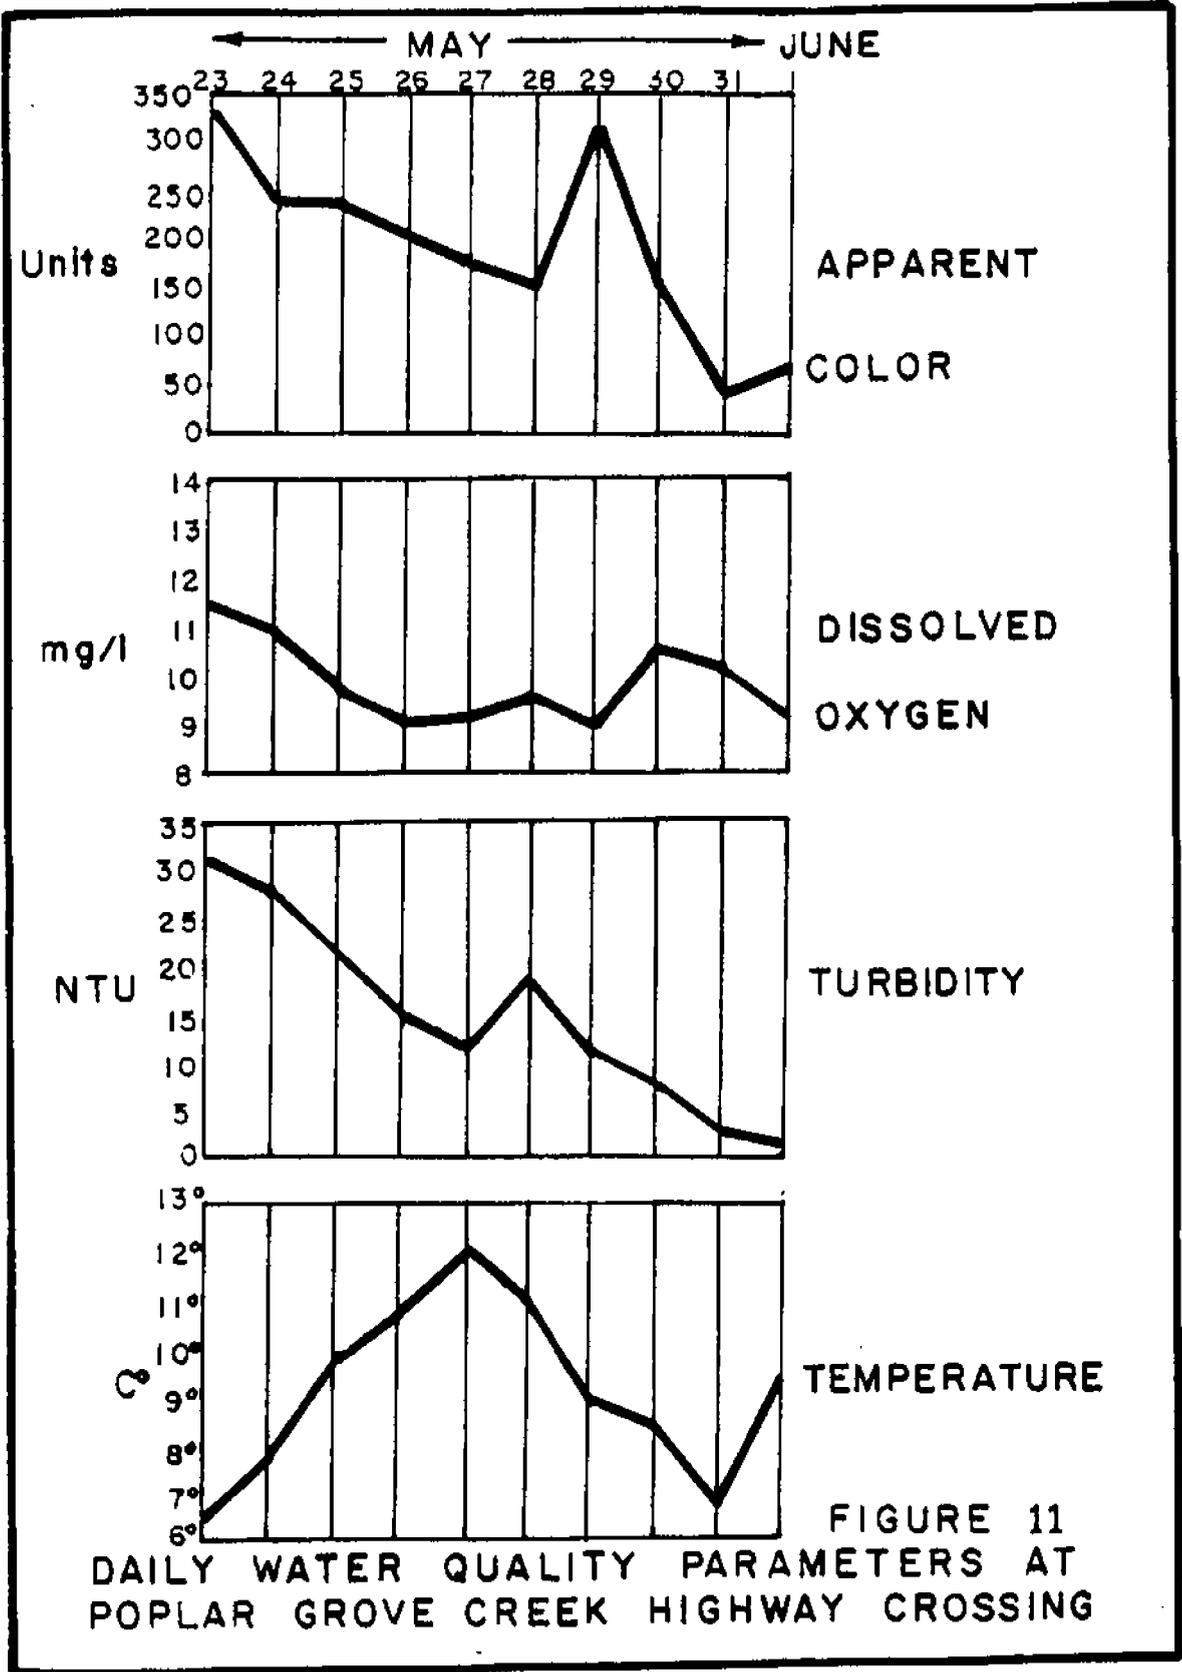
Figure 11 is a graph depicting the water quality vs time for the scour pool during the study period May 23 to June 1, 1985. The maximum daily water temperatures ranged from 6.6°C to 12.0°C, and apparent color fluctuated from 40 to 320 units. Turbidity ranged from 3 Nephelometric Turbidity Units (NTU) to 32 NTU. Dissolved oxygen varied from 9.0 mg/l at a water temperature of 9°C to 11.2 mg/l at a water temperature of 6.5°C.

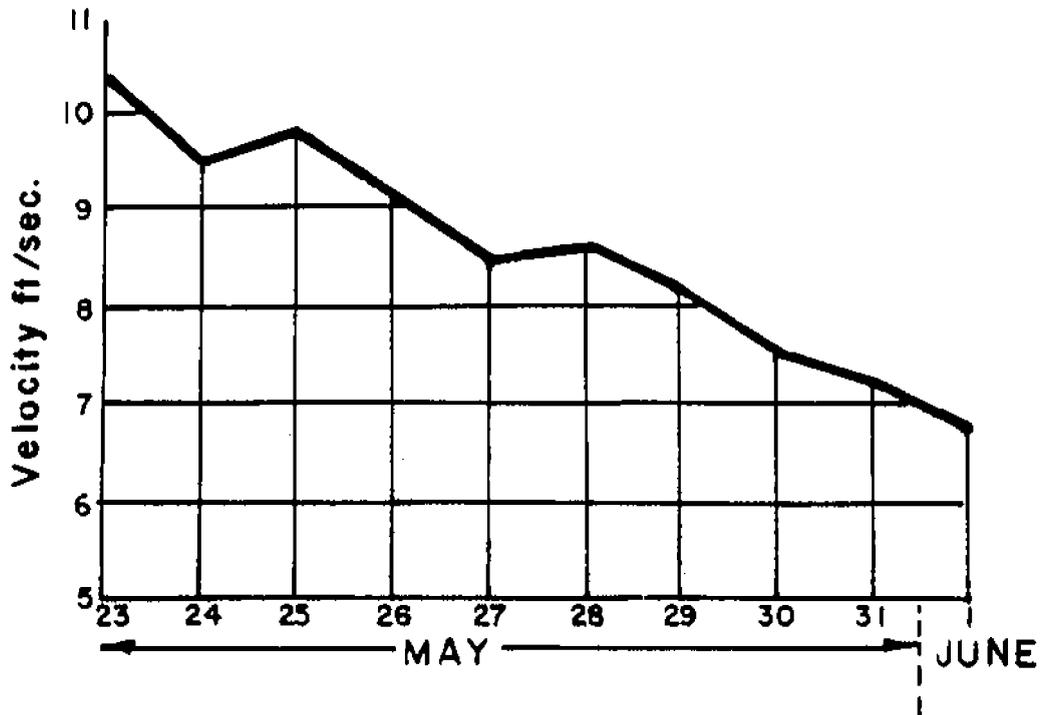
FIGURE 12

DAILY CULVERT AVERAGE CENTERLINE
 OUTLET VELOCITIES AT POPLAR GROVE
 CREEK HIGHWAY CROSSING

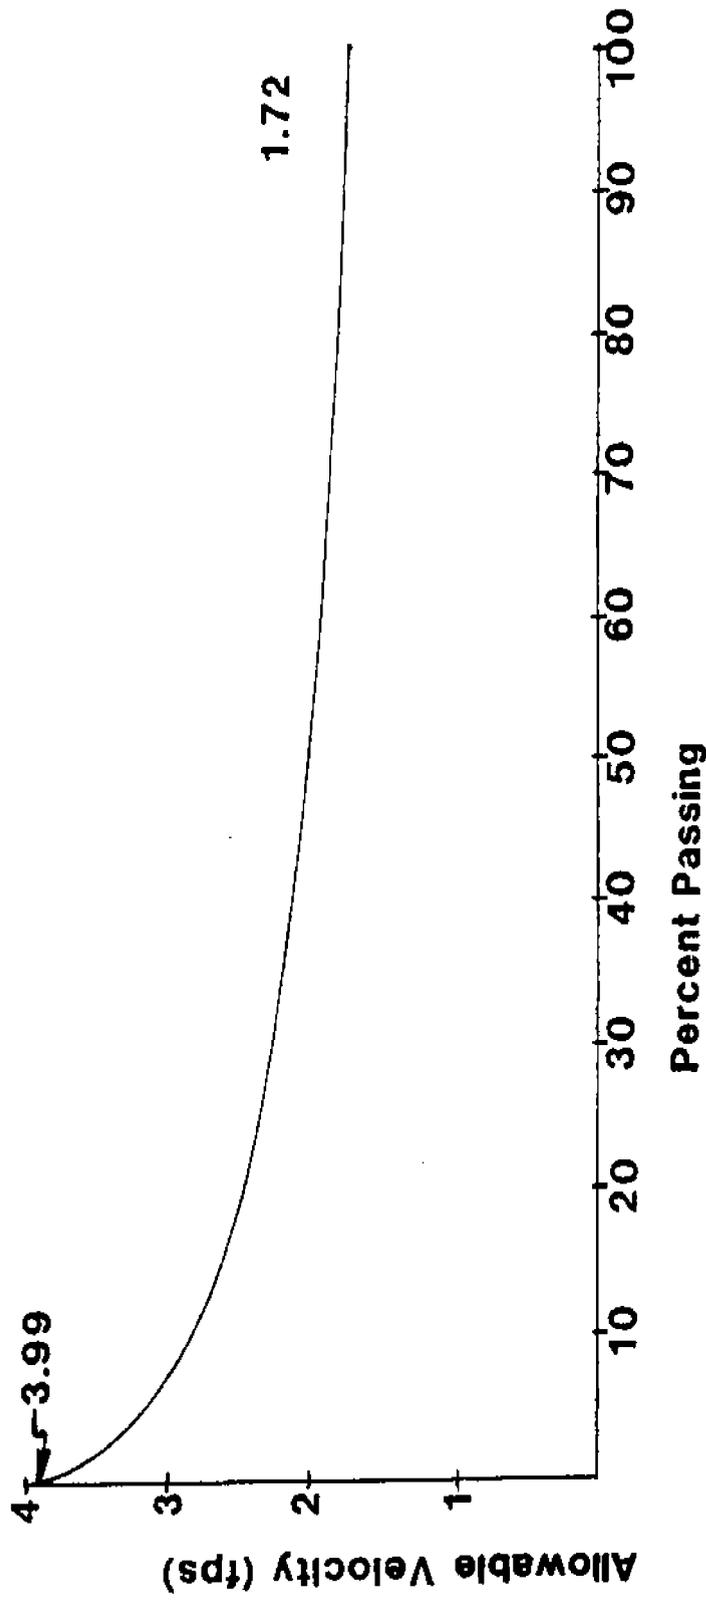
FIGURE 14: AVERAGE CULVERT OUTLET VELOCITIES
GENERATED FROM EQUATION 1 WITH VARIABLE PERCENT PASSING

Figure 14 displays the effects of varying P on the derived average outlet velocities by using equation 1 and setting the CL = 100 ft, FL = 241 mm, and T = 2.78°C. The graph shows that the derived velocities range from about 4.0 fps to 1.7 fps with a change of P from 0% to 100%. According to this formula, no 9.5 in fish are expected to pass a 100 ft culvert when the water velocity exceeds 4.0 fps and the water temperature is 2.78°C.

CL = 100' V = 3.99 - 1.13 log (P+1)

FL = 241mm T = 2.78°C

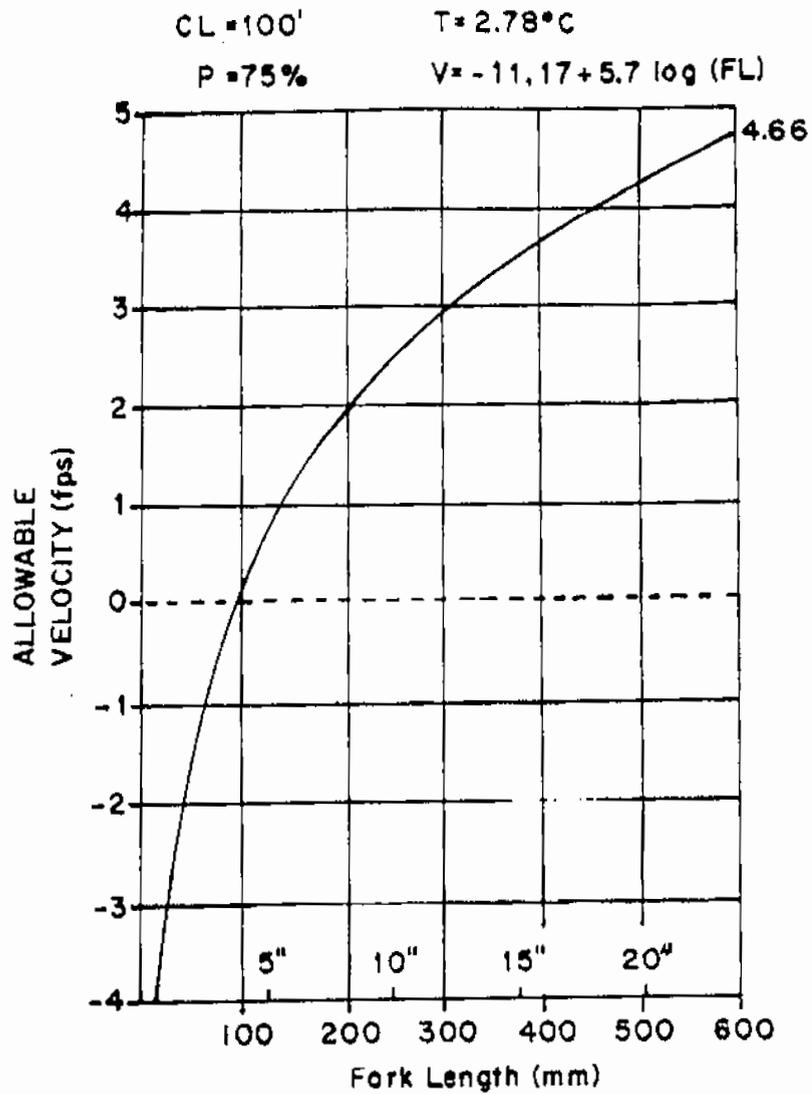
FIGURE 15: AVERAGE CULVERT CENTERLINE OUTLET VELOCITIES GENERATED FROM EQUATION 1 WITH VARIABLE FORK LENGTH

Figure 15 displays the effects of varying FL on the derived average outlet velocities if equation 1 is used and CL = 100 ft, T = 2.78°C and P = 75%. The graph shows that the derived velocities range from about -22.6 fps to 4.7 fps, with a change of FL from 0 m to 600 mm (24.6 in). According to this formula, fish less than 91 mm (3.6 in) would need the assistance of forward moving current (negative velocity) in order for 75% of this size range to pass. Obviously, a negative velocity would not be necessary for a 91 mm fish to pass through a culvert. Again, this illustrates the need for a boundary condition for the equation. It should be noted that MacPhee and Watts (1976) included a group of grayling in the size range of 81 to 100 mm, whereas the smallest fish

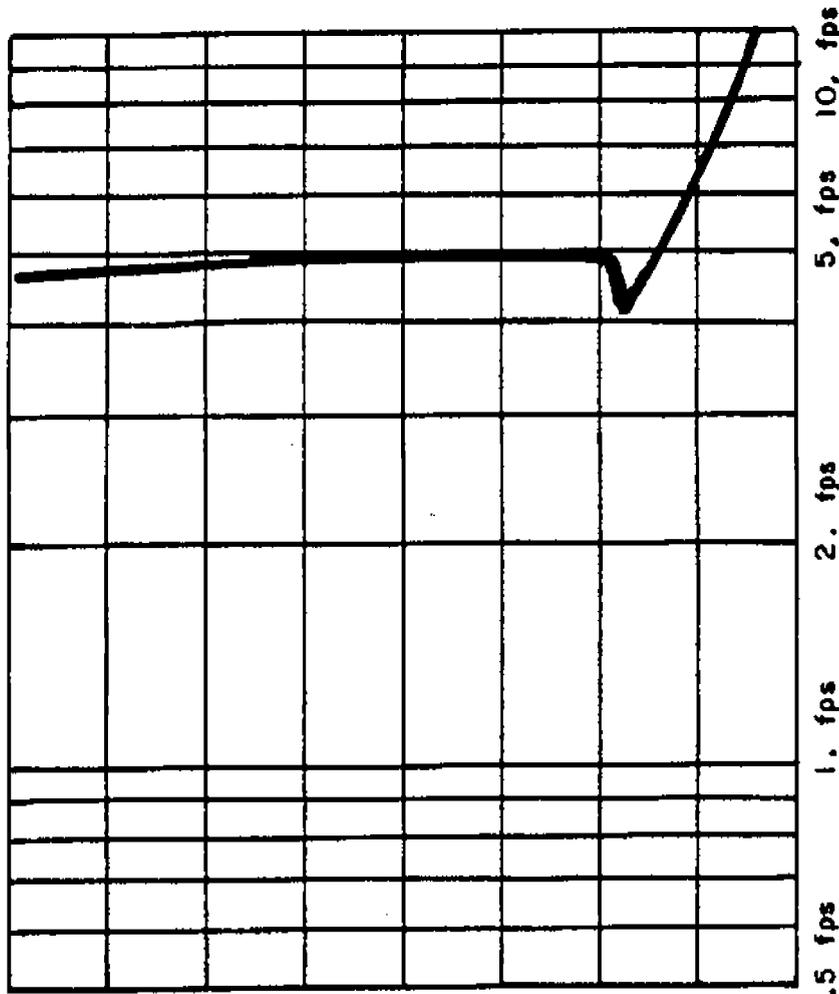
According to Figure 16, the culvert outlet velocities decrease quickly to 4.1 fps as the culvert diameter increases to about 3.8 feet, and then the velocity sharply increases to 5 fps. This is due to the culvert being subjected to discharges greater than its hydraulic capacity when the diameter is less than 3.8 feet. Therefore, culverts with these small diameters develop a hydrostatic head of water at the inlet which creates accelerated velocities at the outlet. At a diameter of 3.8 feet, the culvert is completely full with a HW/D = 1. At this time, the volume of water moving through the pipe is subjected to drag forces from the entire circumference of the culvert. Therefore, the

GIVEN DATA:

$n = .024$
 Slope = .005
 Discharge = 45 cfs

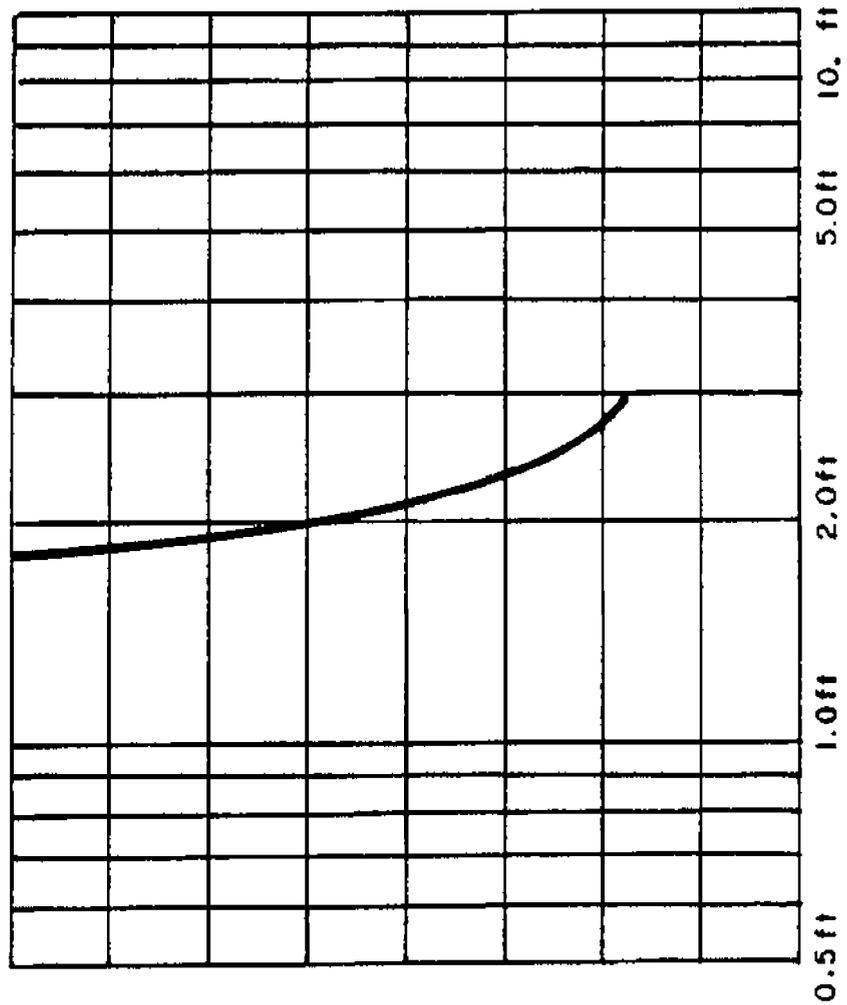
FIGURE 17 PIPE DIAMETER VS DEPTH OF FLOW IN CULVERT

GIVEN DATA:
 $n = .024$
 Slope = .005
 Discharge = 45 cfs

DEPTH OF FLOW IN FEET

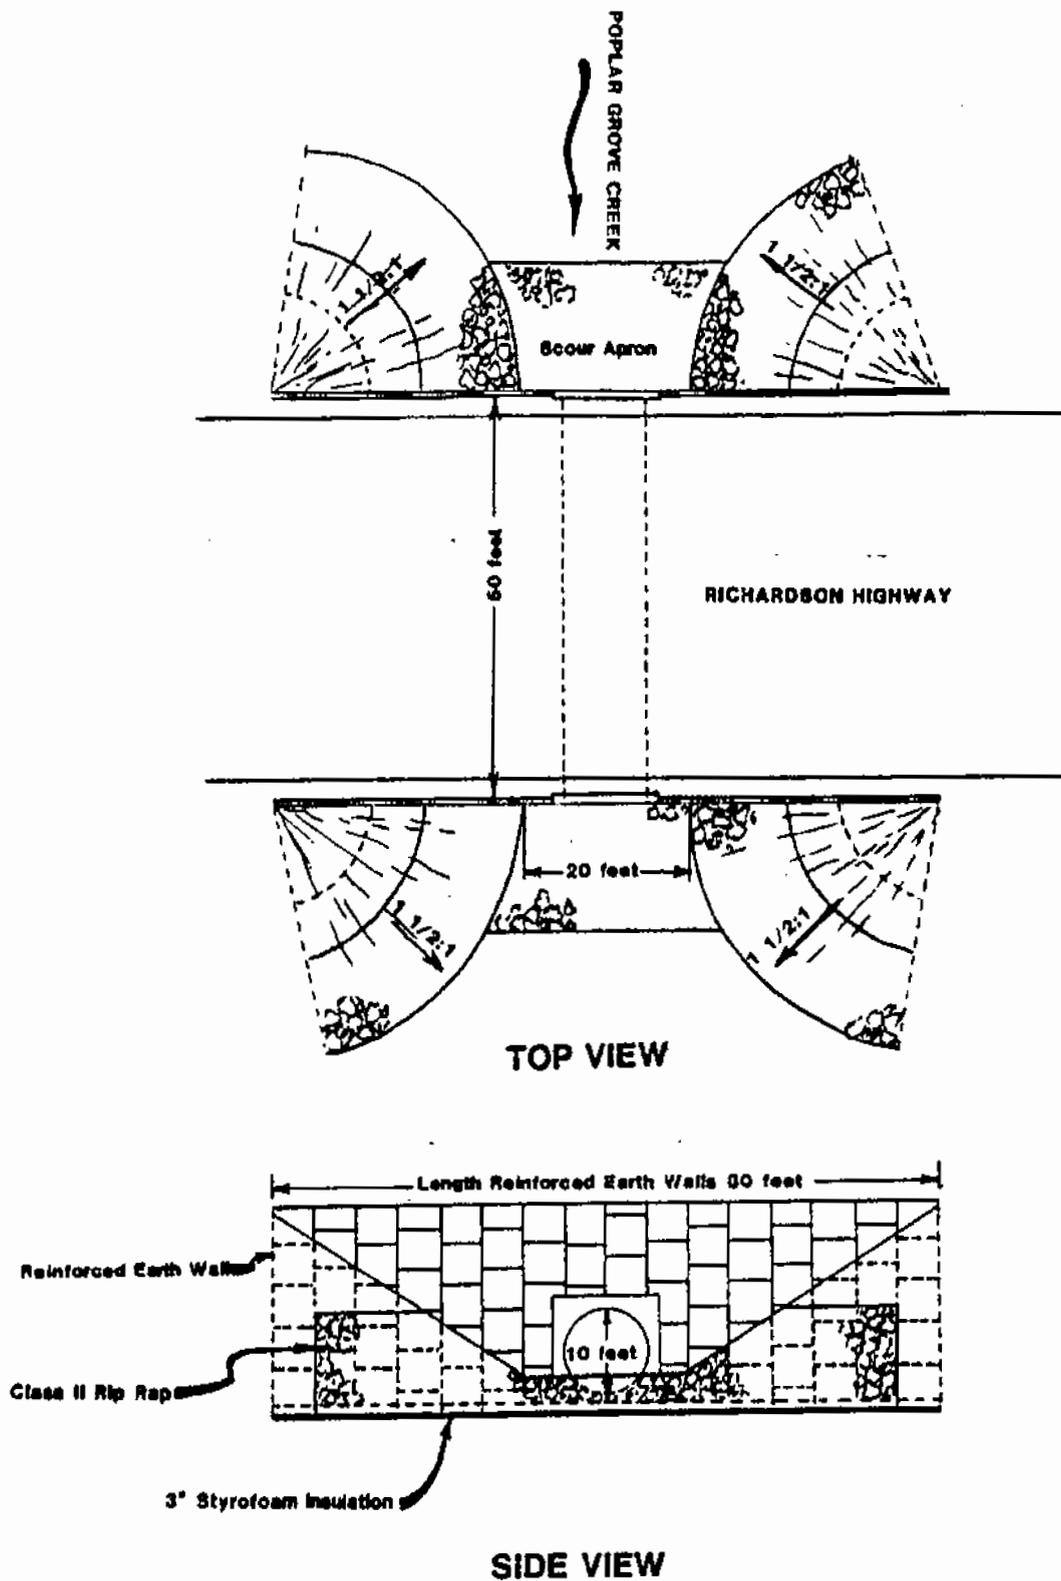
FIGURE 19: FUTURE POPLAR GROVE CREEK STRUCTURE

The highway crossing at Poplar Grove Creek is scheduled to be realigned approximately 300 feet upstream during the 1987 construction season. To attempt to comply with ADF&G fish passage criteria, a 50-foot-long, 10-foot-diameter culvert with reinforced headwalls has been designed (Figure 19). The headwalls support the road embankment, which allows for a shorter pipe length and a higher ADF&G maximum allowable outlet velocity (4.04 fps for a $Q_{2.33}$ from Figure 2). Without the headwalls, an 80-foot culvert would be needed to span the width of the road fill in the stream. The corresponding ADF&G maximum allowable outlet velocity for an 80-foot culvert would be 3.02 fps for a $Q_{2.33}$. Although the 50-foot-long, 10-foot-diameter culvert will still exceed the ADF&G criteria, ADF&G has accepted the proposed structure (Liepitz, 1985). If ADF&G had mandated that DOT&PF strictly adhere to the criteria, then DOT&PF would have been forced to construct a bridge estimated to cost about \$400,000.

The anticipated cost for the proposed structure (50-foot-long, 10-foot-diameter) is approximately \$160,000 (DOT&PF, 1985). The reason for the high cost of the proposed structure is the increased cost for a larger diameter pipe and the increased amount of labor that is needed to construct the reinforced earth headwalls, the scour aprons and the large
